**Re: Mold Assessment and Sampling Report
Commercial Building – 517 Wellington, Traverse City, MI
AQC Project Number: 01511**

SECTION 1.0: INTRODUCTION

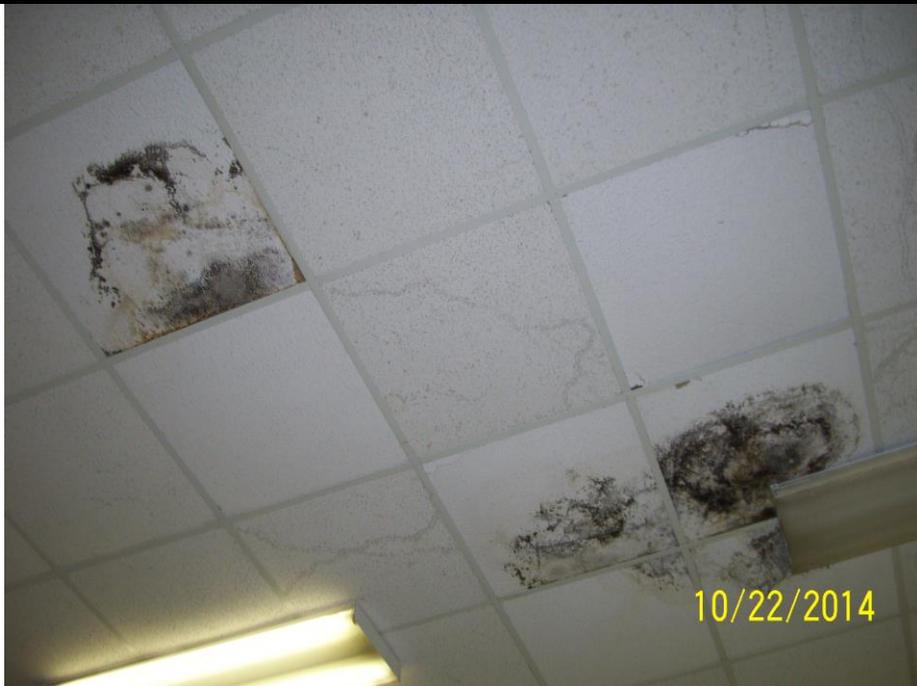
Subject	Mold growth on office ceiling tiles.	AQC Project No. 01511	1
Site	Commercial Building - 517 Wellington, Traverse City, Michigan

- Remove all contents (as described above).
- Remove and dispose of all carpeting, lower four (4) feet of drywall walls and insulation (if encountered), and water and mold damaged ceiling tiles.

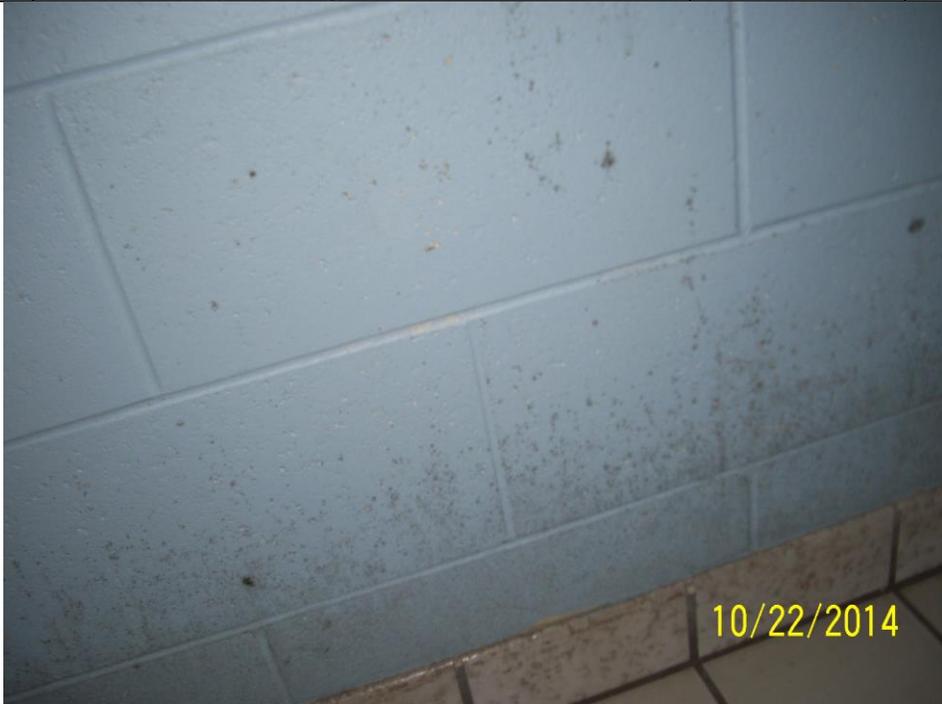
Subject	Mold growth on block wall in bathrooms.	AQC Project No. 01511	2
Site	Commercial Building - 517 Wellington, Traverse City, Michigan

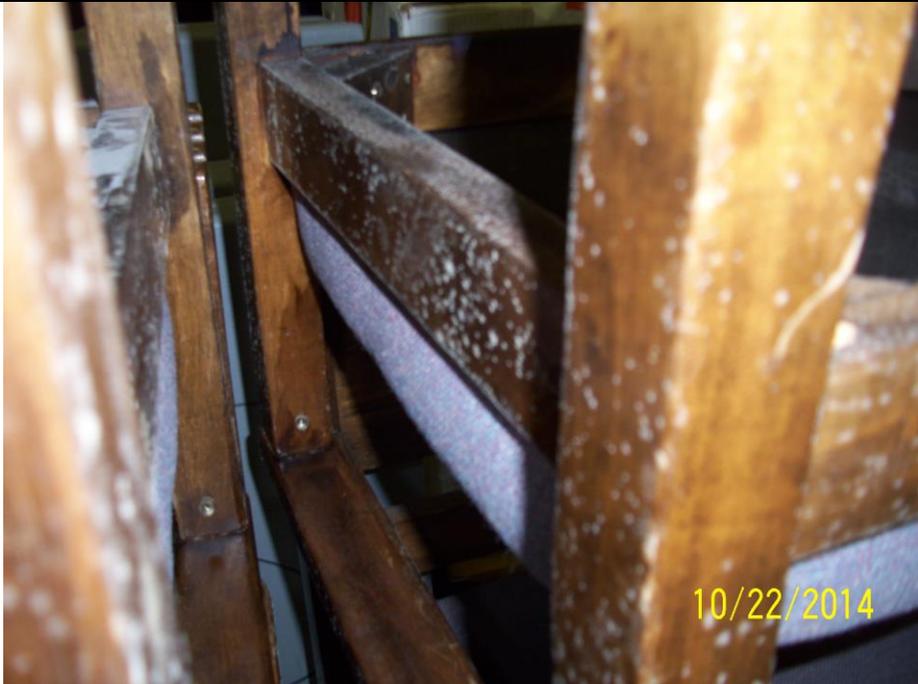
Subject	Mold growth on chairs in main area of office.	AQC Project No. 01511	3
Site	Commercial Building - 517 Wellington, Traverse City, Michigan

- Because of the elevated airborne mold spores present on-site, AQC recommends contents be cleaned off site.
- Disposal of items that are not practical to clean.
- HEPA vacuum and/or wet wipe all contents with hard surfaces.
- HEPA vacuum, launder and/or steam clean all contents with fabric or porous surfaces. AQC suggests that fabric and porous items that can not be laundered be considered for disposal.

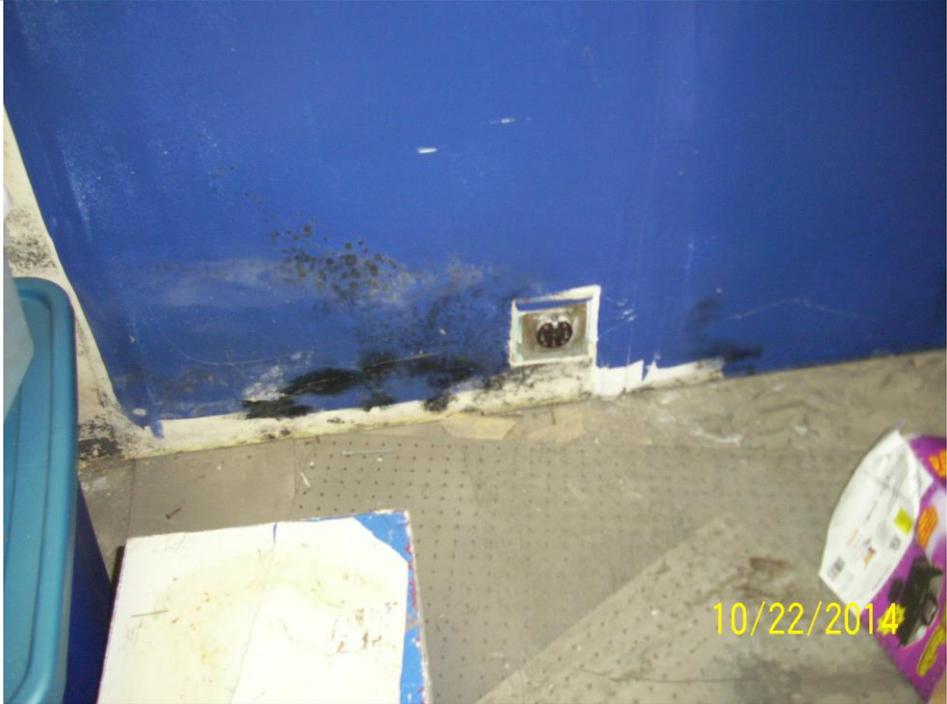
Subject	View of mold in the office adjoining the art and crafts room.	AQC Project No. 01511	4
Site	Commercial Building - 517 Wellington, Traverse City, Michigan

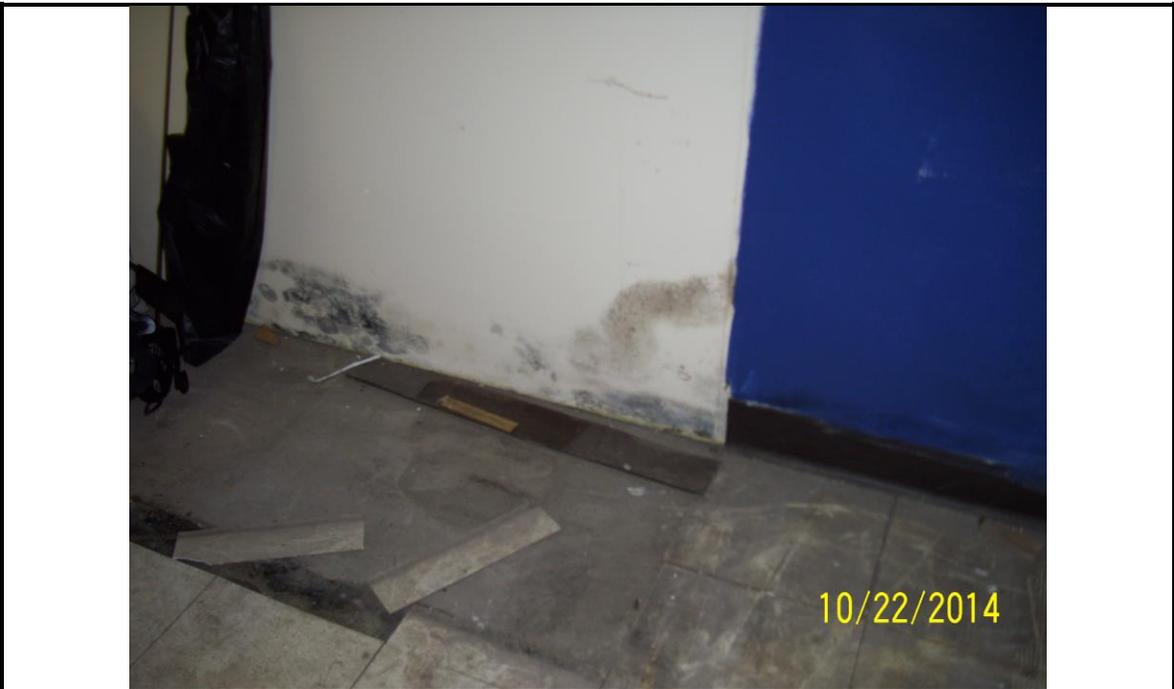
Subject	Another view of mold growth on lower walls.	AQC Project No. 01511	5
Site	Commercial Building - 517 Wellington, Traverse City, Michigan

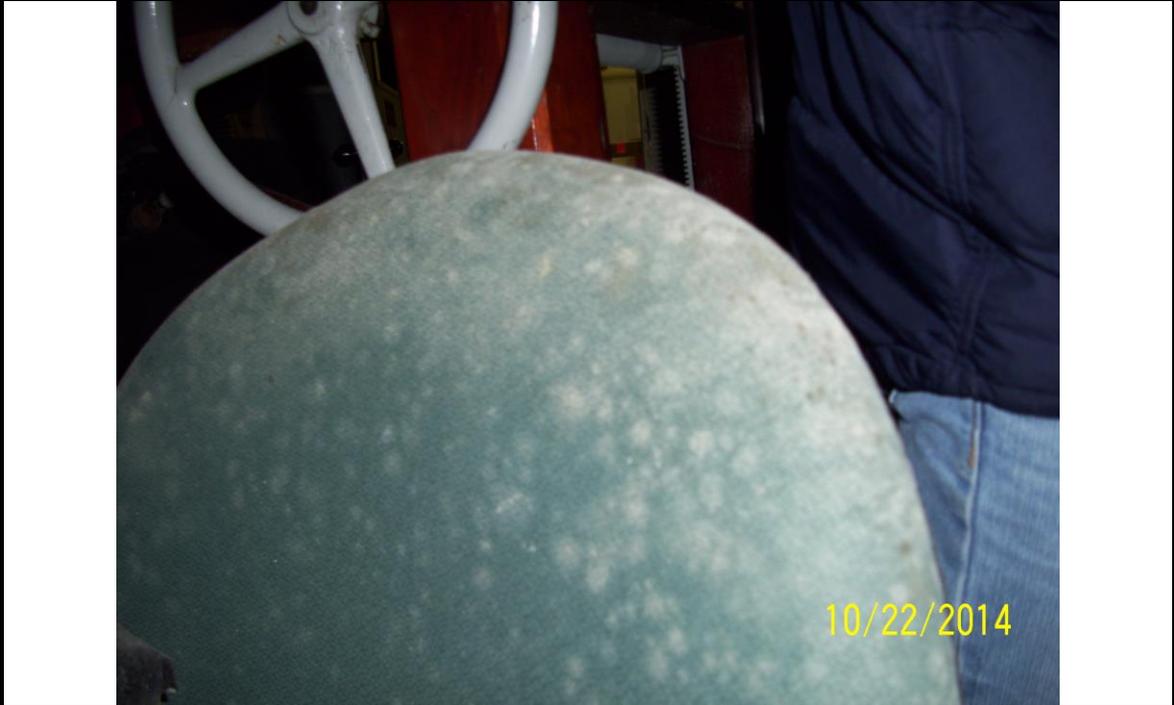
Subject	View of mold growth on contents in art and crafts room.	AQC Project No. 01511	6
Site	Commercial Building - 517 Wellington, Traverse City, Michigan

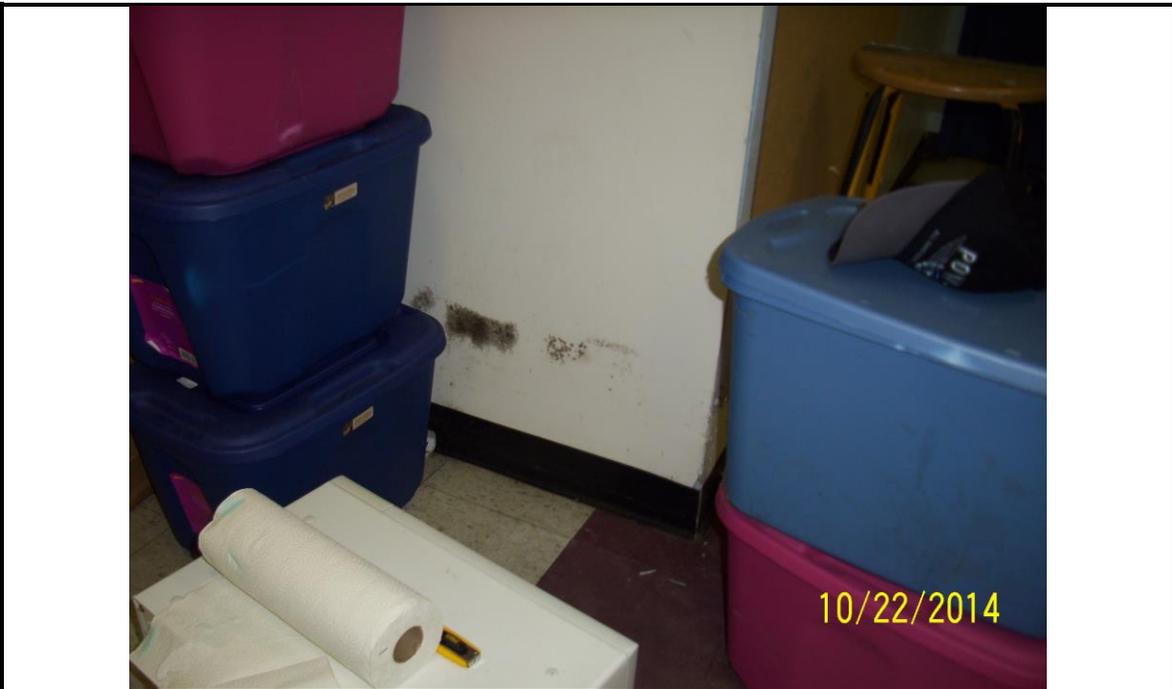
Subject	Mold growth on wall of office adjoining computer room.	AQC Project No. 01511	7
Site	Commercial Building - 517 Wellington, Traverse City, Michigan

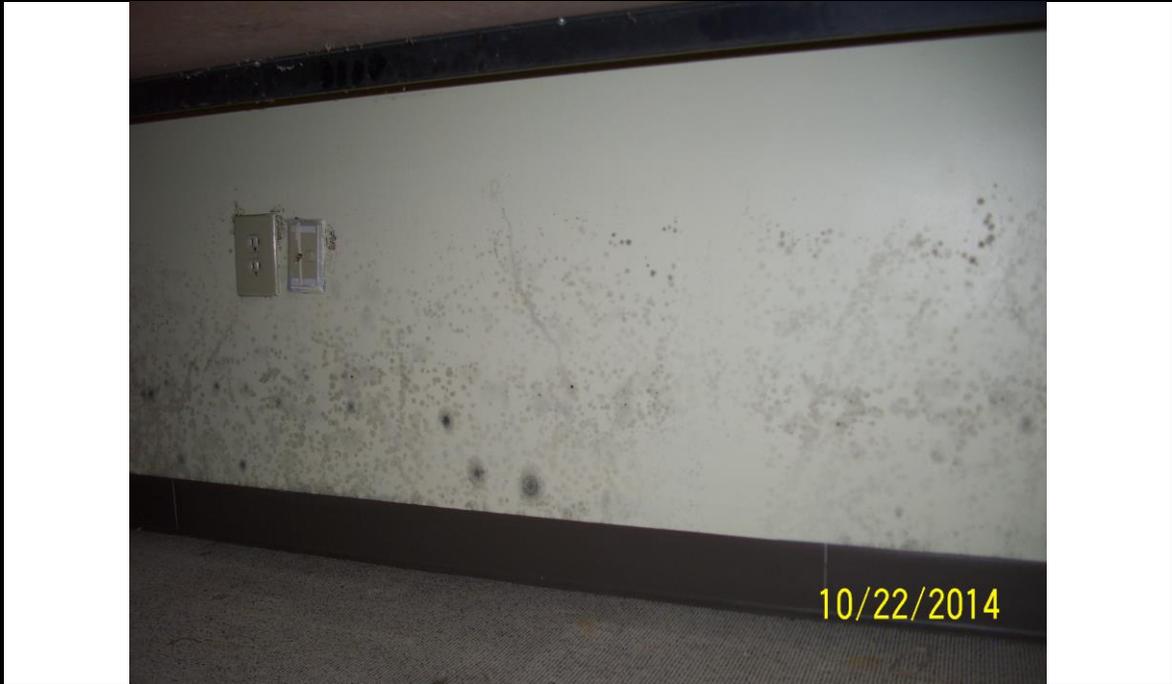
Subject	Mold growth on wall in office adjoining computer room.	AQC Project No. 01511	8
Site	Commercial Building - 517 Wellington, Traverse City, Michigan

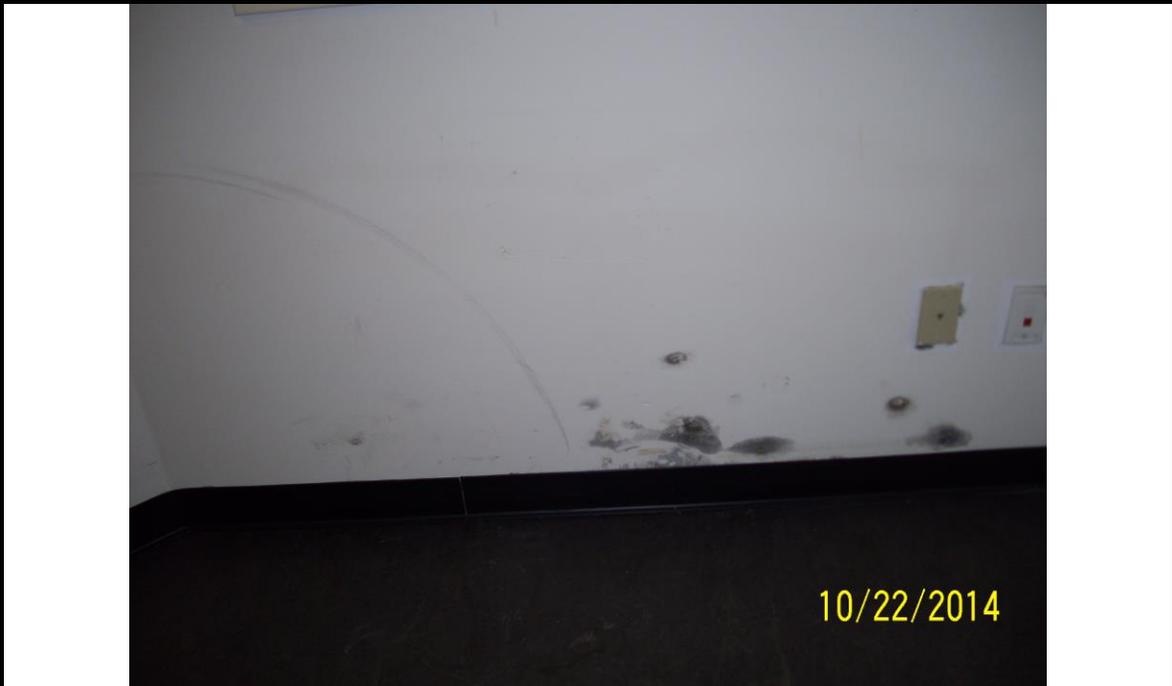
Subject	View of mold growth on wall in office near the gym entrance.	AQC Project No. 01511	9
Site	Commercial Building - 517 Wellington, Traverse City, Michigan

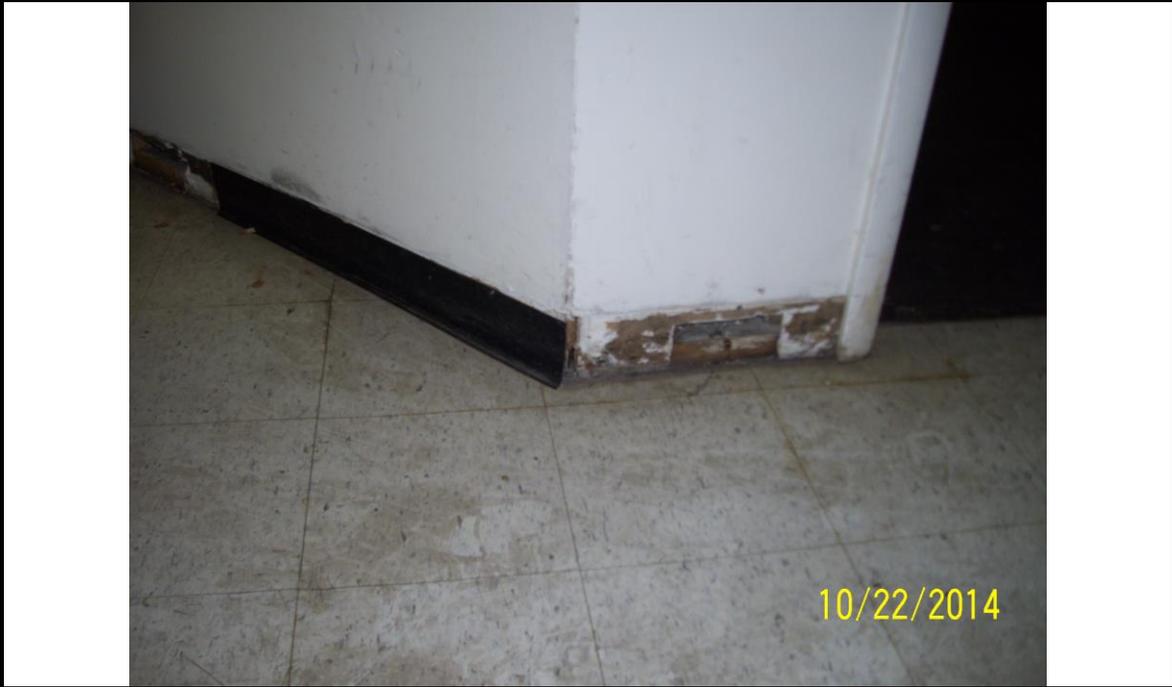
- AQC observed some areas with removed baseboard and some missing drywall under the removed baseboard which indicates a previous water event that someone attempted to dry

Subject	View of removed baseboard and drywall which appears to be a previous drying attempt.	AQC Project No. 01511	10
Site	Commercial Building - 517 Wellington, Traverse City, Michigan
