2023 Infrastructure Evaluation And Capital Improvement Plan

Grand Traverse Commons

For: Grand Traverse Commons Joint Planning Commission

October 9, 2023
GFA Job No. 22286
HRC Job No. 20220549

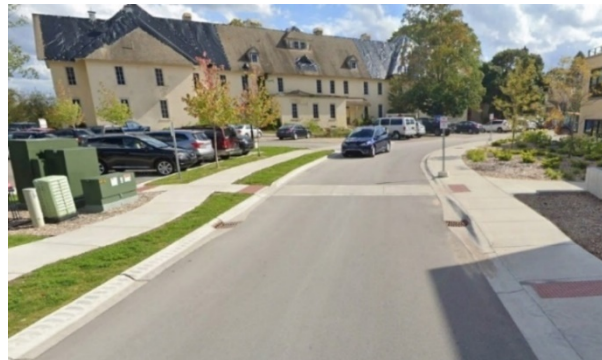
Figure 5.2: Image of Good Pavement with Rating of 9 on Red Drive

Pavements in good condition are represented by a rating between 8 to 10 (4 for brick) and have very few, if any, defects. Pavements in this condition require routine maintenance, such as street sweeping or drainage cleaning, and have been newly constructed. **Figure 5.2** shows an image of a pavement in good condition with a rating of 9 on Red Drive between Gray Drive.

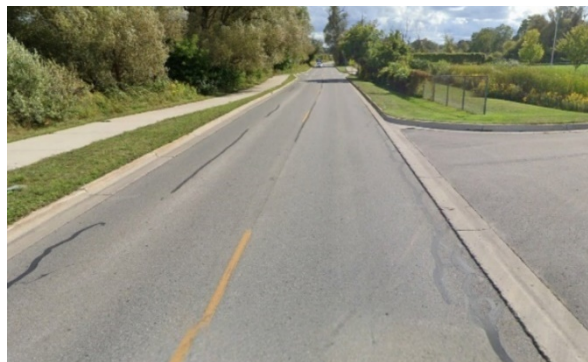
Figure 5.3: Image of Fair Pavement with Rating of 5 on Silver Drive

Pavements in fair condition are represented by a rating between 5 to 7 (2 for brick) and their surface is starting to deteriorate. Pavements in this condition require preventative maintenance, such as joint or crack sealants. **Figure 5.3** shows an image of a pavement in fair condition with a rating of 5 on Silver Drive between Red and Brown Drive.

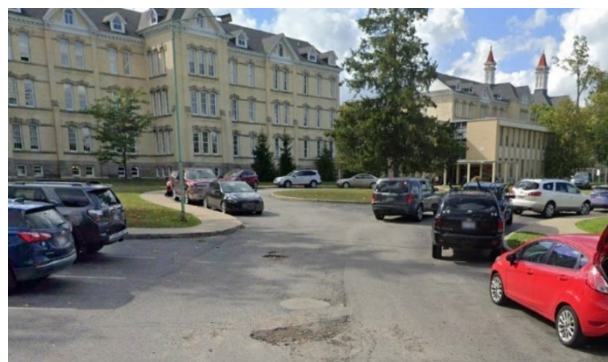
Figure 5.4: Image of Poor Pavement with Rating of 2 on 11th Street

Pavements in poor condition are represented by a rating between 1 to 4 (1 for brick) and exhibit evidence their underlying structure is failing. Pavements with a rating of 4 typically start showing the first signs of structural weakening. Pavements in this condition require structural improvements, such as rehabilitation or reconstruction. **Figure 5.4** shows an image of a pavement in poor condition with a rating of 2 on 11th Street west of Silver Drive.

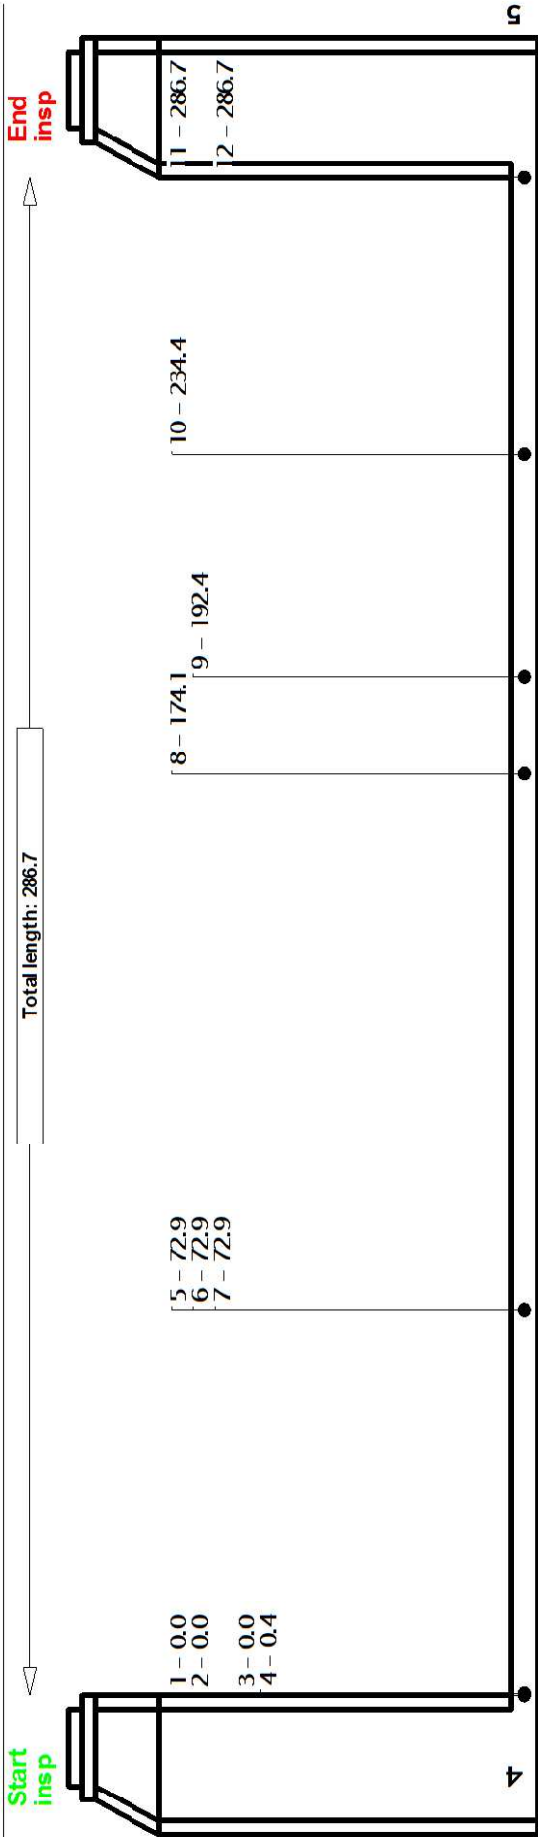
1 - 0.0 <Start inspection> at 10:07:52
2 - 0.0 Manhole
Starting manhole: 4
3 - 0.0 Miscellaneous Water Level 15,000 %
4 - 0.4 Fracture Circumferential At 7 To 5
5 - 72.9 joint Separated Large
6 - 72.9 Intruding Sealing Material Ring 0.000 % At 6 To 6
7 - 72.9 Miscellaneous Material Change
Material changes TO RCP
8 - 174.1 Miscellaneous Water Level 25,000 %
9 - 192.4 Miscellaneous Water Level 15,000 %
10 - 234.4 Miscellaneous Material Change
Material changes TO VCP
11 - 286.7 Manhole
Finishing manhole: 5

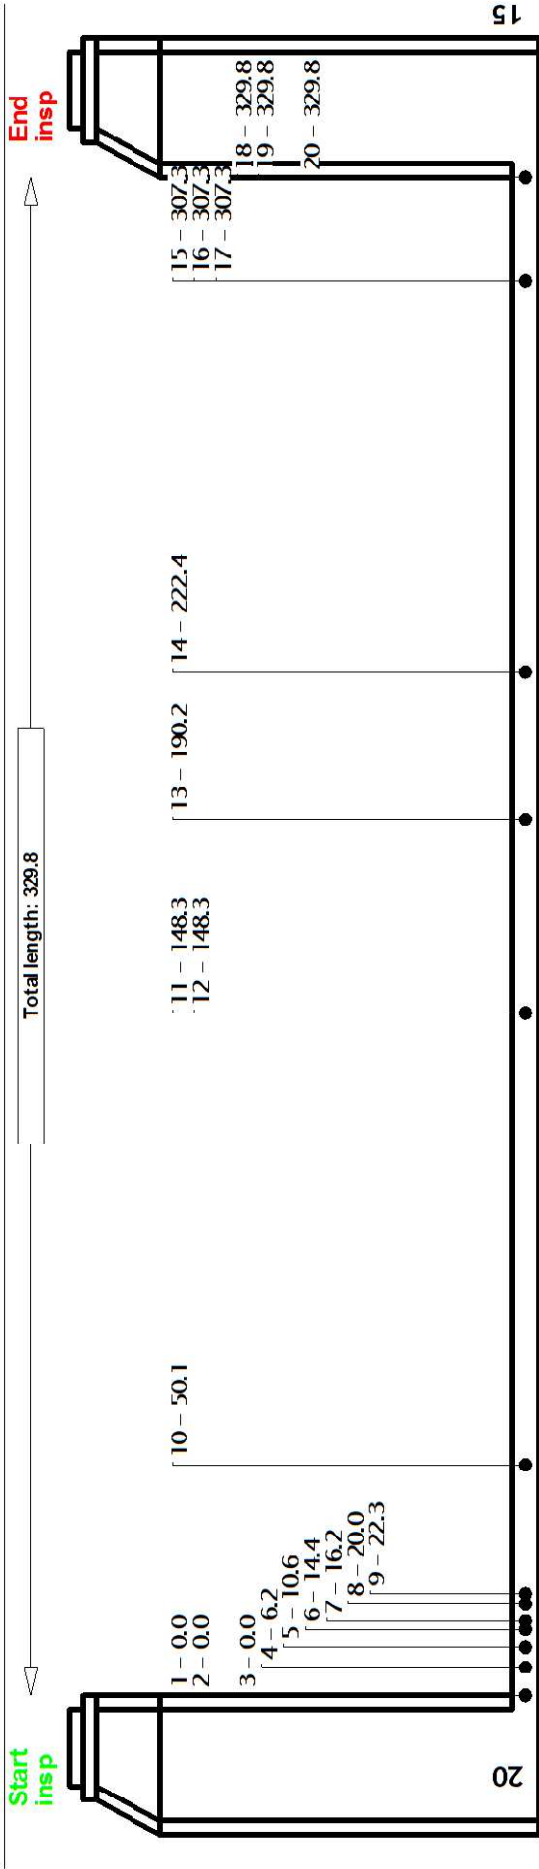
- 1 - 0.0 <Start inspection> at 11:38:57
- 2 - 0.0 Manhole
- 3 - 0.0 Miscellaneous Water Level 5.000%
- 4 - 6.2 Broken At 11 To 3 At Jnt
- 5 - 10.6 Fracture Circumferential At 3 To 7 At Jnt
- 6 - 14.4 Roots Fire joint At 8 To 10 At Jnt
- 7 - 16.2 Roots Fire joint At 9 To 3 At Jnt
- 8 - 20.0 Roots Fire joint At 7 To 5 At Jnt
- 9 - 22.3 Broken At 11 To 2 At Jnt
- 10 - 50.1 Roots Medium joint 15.000% At 8 To 4 At Jnt
- 11 - 148.3 Tap Factory At 12 Dia 0.000
- 12 - 148.3 Miscellaneous Material Change
- 13 - 190.2 Broken At 1 To 5
- 14 - 222.4 Tap Break-in/Hammer At 12 Dia 0.000
- 15 - 307.3 Roots Fine Joint At 7 To 5 At Jnt
- 16 - 307.3 Miscellaneous Water Level 50.000%
- 17 - 307.3 Deposits Settled Fire 40.000% At 4 To 8
- 18 - 329.8 Deposits Settled Fire 40.000% At 4 To 8
- 19 - 329.8 Manhole
- 20 - 329.8 <Complete Inspection inspection> at 12:19:05

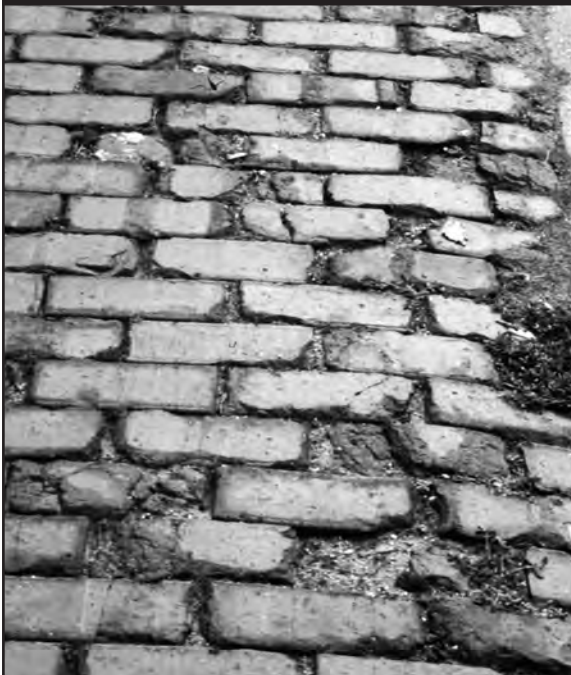
Broken bricks and rough surface over extensive area.

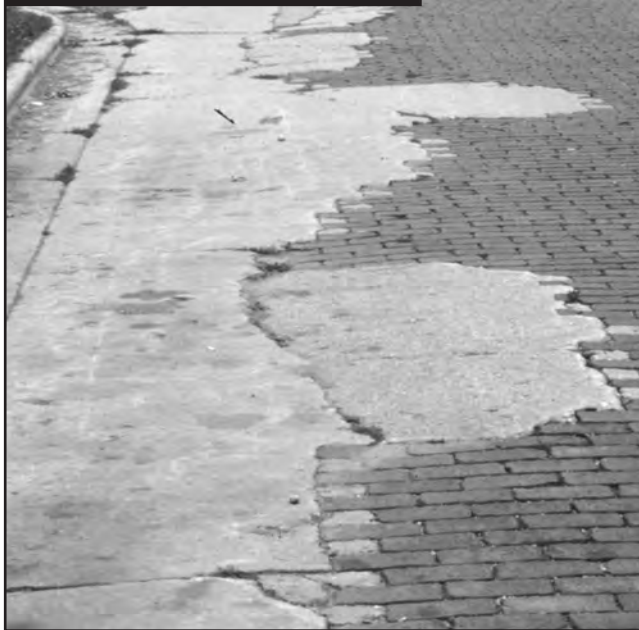
Extensive patching in poor condition.

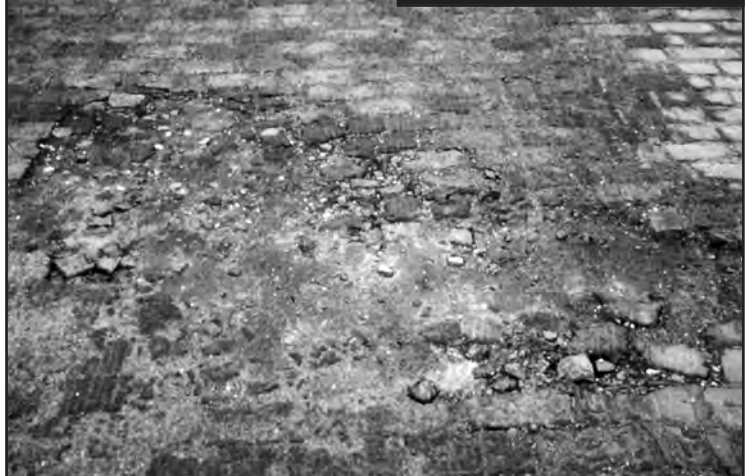
Severe brick deterioration.
