# Facility Evaluation for Fire Dept. Transport Study

City of Traverse City

April 25, 2022

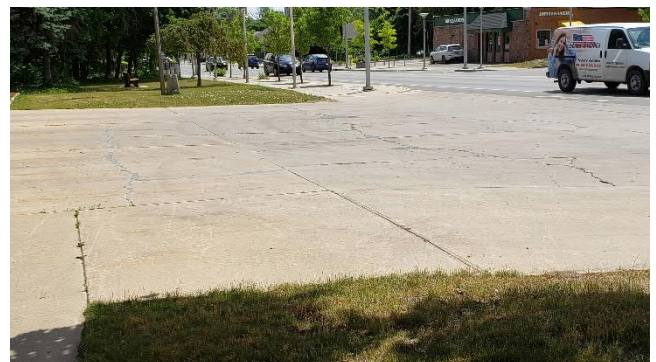
Figure A1.7

The fire station apparatus bay aprons are 6" reinforced concrete slabs the width of the bays and extend to the roadway curbs and are cracking badly (Figures A1.7 and A1.8). There is a fire hydrant at the north side of the training tower at the alley connected by a 6" buried water main. The building is serviced by a 2" water connection off the main and there is a 2 ½" service (unmetered) to the training tower. Other services (power, gas, sanitary sewer) are provided from utilities in the north alley. Storm (and roof) water appears to be piped to city storm sewers.

8. Remove the existing cracked truck aprons and replace with new, thicker reinforced concrete aprons on compacted sand fill.
9. Replace electrical switchgear with new throughout the building and increase service size to accommodate cooling electrical loads.

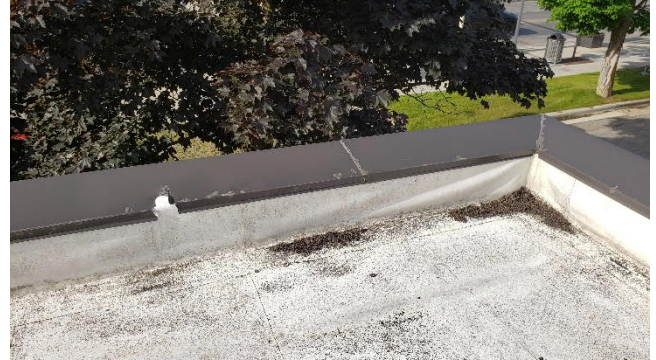
Figure A1.9

The roof consists of a white single ply membrane over rigid insulation of unknown depth and R-value, but appears in good condition with no visible problems, other than removing moss and debris buildup in low pockets (Figure A1.9) and at roof drains. Several of the cast iron drain strainers are broken/cracked and should be replaced. We were informed (from the RFP) that the roof is older and portions of the roof were replaced in 1993; typically roof warranties are 20 years. Minor roof leaks have stained the suspended ceiling tiles that appear to be localized along walls, pointing to wall and cap flashing issues. We would recommend taking cores to evaluate the roof insulation condition and R-value. We also recommend getting thermal scan of the roof to see there is wet insulation present. The metal wall copings are in good condition, however, the section joints need new caulking and several cut coping panels (Figures A1.10-A1.12) should be replaced with new to prevent cutting the membrane and provide a complete cover of the tops of the parapet walls. The soffits appear to be cement plaster, or direct applied stucco, on exterior gypsum board that are exhibiting some wear (Figures A1.13 and A1.14) and deterioration at several locations, especially over the apparatus bay doors.

6. Replace all roofing and roof insulation. Install a single ply system such as EPDM or TPO and new insulation to meet current ASHRAE recommendations.
7. Replace windows with new to improve thermal performance and allow for better occupant use. New glazing system should be thermally broken frame with 1" insulated glass. The glass should have a low emissivity coating and ideally should be clear glass to maximize daylight into the building and also to allow passersby to see activity within the station.

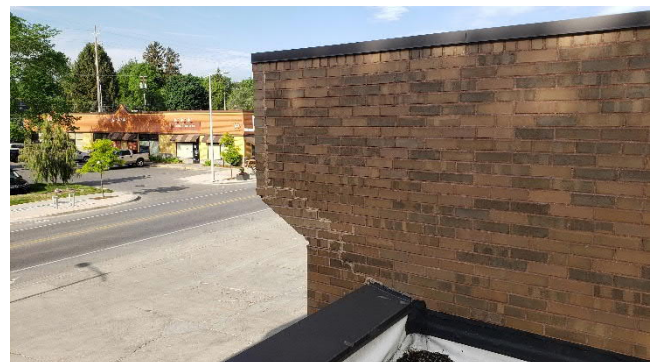
Figure A1.15

The all-masonry building is in fairly good condition, however, several cracks have appeared over the years around the building. The cracks (Figures A1.15-A1.17) have been repaired with both mortar and caulk that appear to be from water freeze-thaw cycles when water finds its way into the joint between the facebrick veneer and concrete block backup walls. There are areas on the chimney that need tuck-pointing, primarily at the top perimeter (Figures A1.18 and A1.19). Another concern (Figure A1.20) is the rusting steel lintels at the door openings and over the apparatus bay doors. The brick on some piers and at the base of the patio stair wall (Figure A1.21) exhibit face shells spalling off with more face shell cracking evident directly above. All the sloped brick window sills have facebrick/mortar joint failure (Figures A1.22-A4.24) allowing water to migrate behind and push/lift the lower courses out and crack the brick.

4. Replace front door with new thermal broken unit to improve thermal performance. At the same time adjust the swing in the direction of egress.
5. Repair exterior brick by tuckpointing mortar joints and reconstruct severely damaged areas. After completion, apply a sealer recommended for facebrick to the complete exterior to reduce water penetration into the wall

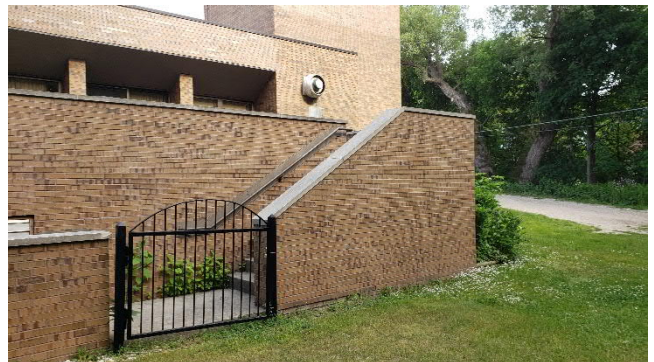
Figure A1.36

The patio structure is in fair condition and showing its age at the facebrick perimeter walls where water damage (freeze/thaw) is visible, primarily at the lower east wall north of the gate and at limestone wall cap joints (Figure A1.34). The concrete floor slab is in good condition with minimal cracking and 'sheet' drains via the concrete steps (good condition), however, the joints at the perimeter walls are heavily caulked (Figure A1.35) to prevent water damage to the brick walls. The steel gate door and posts are in good condition, but settling unevenly (Figure A1.36)

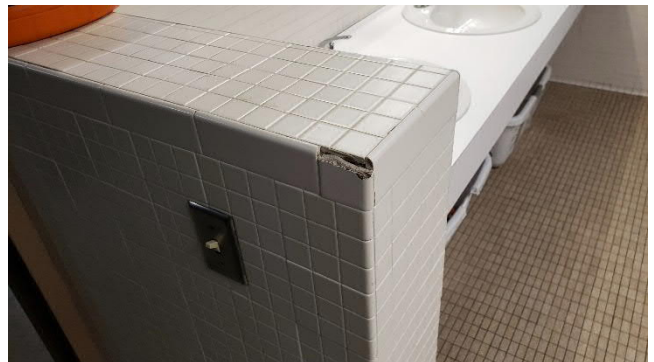
Figure A1.38

The current Men's only restroom (Figure A1.37) has 2 water closets, 2 floor mounted urinals, 2 shower stalls and 3 lavatories. The overall condition is good, however, the wing wall has broken/missing ceramic tile (Figure A1.38) on the top surface corner and is non-compliant to ADA and MI-BF requirements, though, not necessary to be for a fire station use. The toilet partitions are the original ceiling and wall hung painted metal pieces that appear to be in good shape, but painted several times.

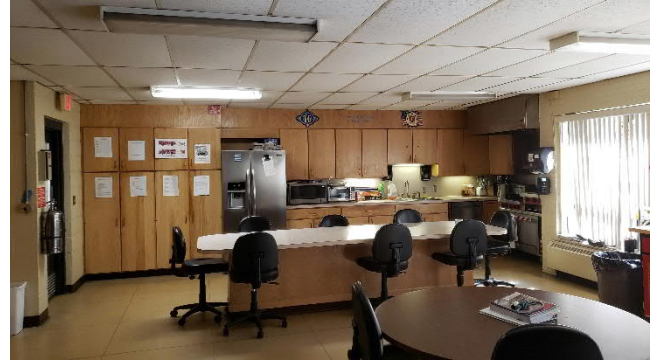
Figure A1.41

Suspended 2x4 acoustic tile ceiling systems are prevalent throughout the facility including the apparatus bay. The tiles are sagging due to age and moisture absorption (Figure A1.41) over the years with water stains in several rooms (Figures A1.39 and A1.40) from roof leaks. Following the repair of any roof leaks, it is recommended to replace the ceiling tile and grid as it will improve the overall appearance of the spaces. The workout room (former locker room) now has painted exposed roof structure (black). The bottom side of any exposed precast concrete floor panel is painted on the main floor and unpainted in the basement.

1. Replace all non-lever door hardware with lever style hardware to improve building accessibility.
2. Repaint walls to update appearance.
3. After any above ceiling or roof work is complete, replace ceiling tiles and ceiling grid to update appearance and eliminate stained tiles.

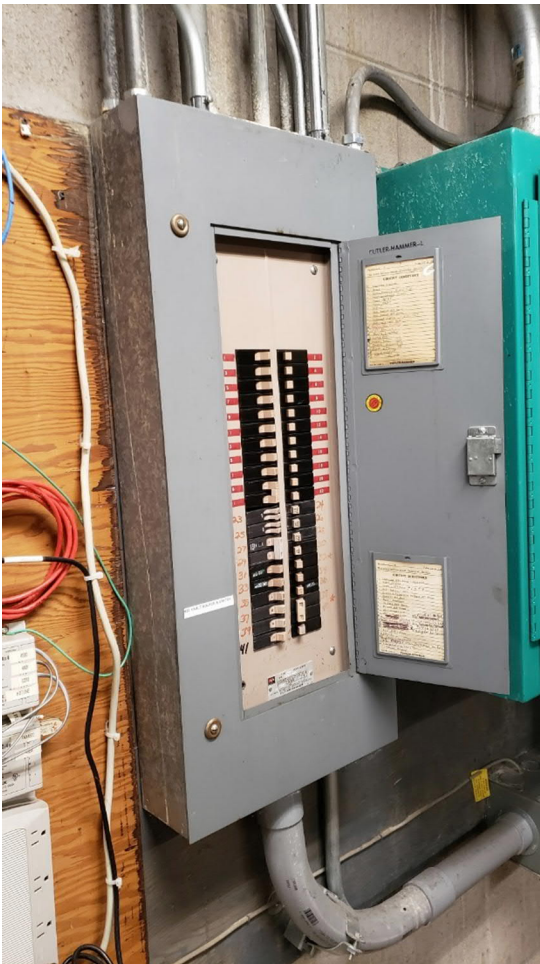
It is believed that the primary electrical service panels were installed in the mid-1970s. Manufacturer's typically recommend a service life anywhere from 20 – 40 years depending on maintenance, installation location, among other various factors. Electrical panels that are approximately 45-50 years old are well beyond the manufacturer's recommended service life. These should be replaced as soon as possible. Replacement parts for these panels are obsolete and/or not available. Further, it is understood that air conditioning for the building is desired. This upgrade will need to be coordinated with the utility company as it will require a larger service and corresponding electrical panel(s).

Figure E1.1 Incoming Service Equipment

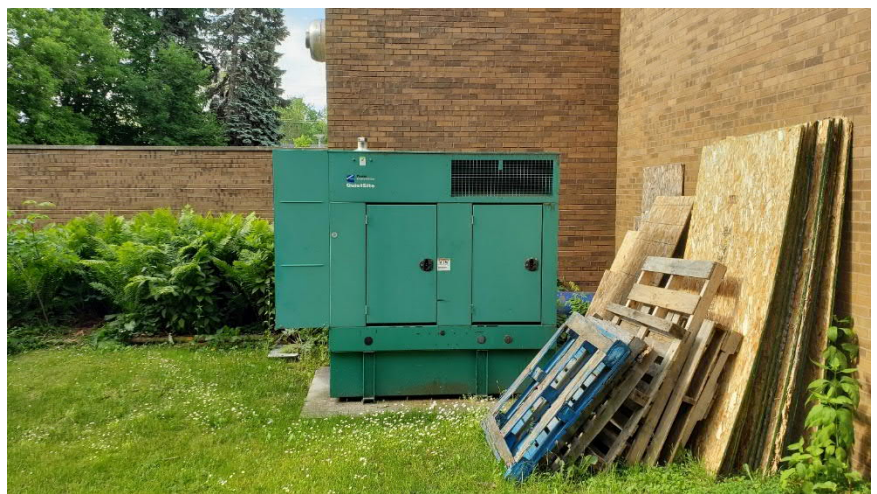
Electrical service to the Traverse City Fire Station #1 is via an underground feed from Traverse City Light & Power near the northeast corner of the building. A 35kW emergency diesel generator is located outside near the service entrance and supplies emergency loads for the building through an automatic transfer switch (ATS). It is fueled from an underground tank. This unit was built in 2003 and appears to be in fair condition. The main service and emergency panels are both rated 120/240V, single phase, 3 wire. The main panel is 200A and emergency is 150A. Each panel appears to be original to the building and have exceeded the manufacturer's recommended service life.

Figure E1.2 Emergency Generator

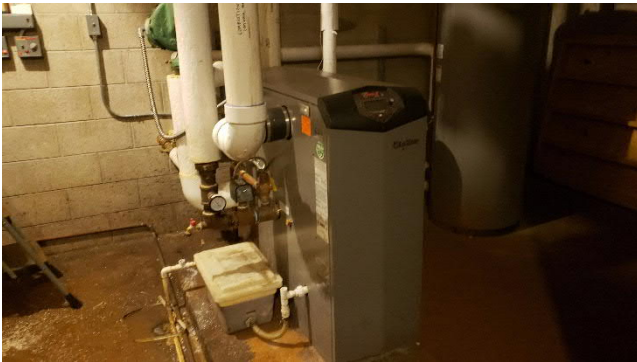
The existing heating system is for the most part original. However, the original cast iron sectional boiler was replaced in 2013 by a high-efficiency Lochinvar Knight condensing boiler with a nominal output rating of 710,000 Btuh at 95% rated efficiency. Concurrent with the boiler replacement project, the original hydronic distribution system was converted from multiple zone distribution pumps to a single system pump with zone control valves. The existing Lochinvar boiler is 8 years old and has an anticipated life expectancy of 15-20 years. Future heating system upgrades should include a second boiler to provide redundancy in the event one boiler fails.

Figure M1.1 Existing Lochinvar Boiler (in basement)

20. Upgrade boiler heating system to include two parallel boilers for redundancy in the event one boiler fails.
21. Replace aging terminal heating units, they are old and should be replaced in the near future. Newer heating units will provide for improved occupant comfort, controllability and energy efficiency.

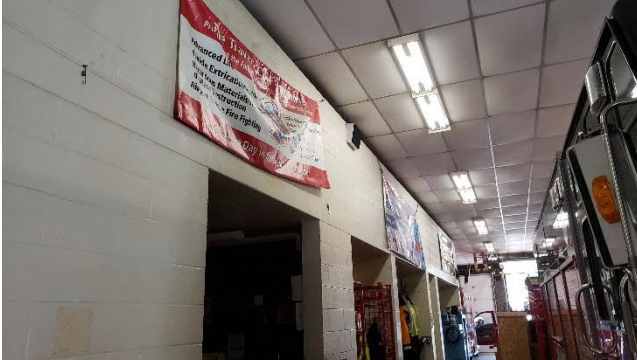
The Apparatus Bay currently has no vehicle exhaust detection and ventilation system. For the safety of building occupants, it is recommended that a new vehicle exhaust detection system be installed to monitor for unsafe levels of carbon monoxide and nitrogen dioxide. The system would include alarm devices as well as an exhaust fan to purge the bay with fresh air. It is also recommended that some form of exhaust capture equipment be added to the Apparatus Bay to minimize the accumulation of exhaust gases. Common capture systems include AirVac911 suspended units or PlymoVent snorkel units.

Figure M1.13 Apparatus Bay (no gas detection or exhaust system)

16. Add vehicle exhaust detection and ventilation system for Apparatus Bay. For the safety of building occupants, it is recommended that a new vehicle exhaust detection system be installed to monitor for unsafe levels of carbon monoxide and nitrogen dioxide. The system would include alarm devices as well as an exhaust fan to purge the bay with fresh air for meet current code requirements.

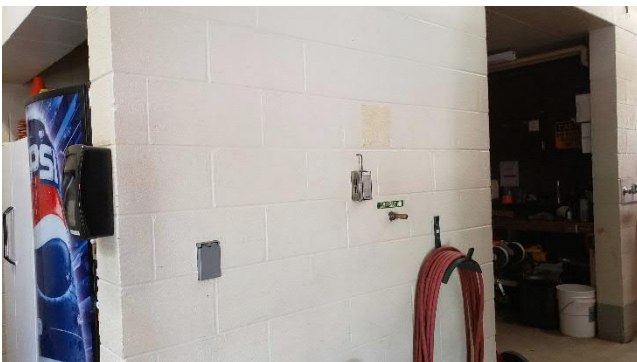
The temperature controls for the Station are primarily the original pneumatic (compressed air) devices. Each space has a thermostat which controls modulating heating valves for the heating units. Each A/C unit includes a separate temperature sensor for cooling set points. An air compressor in the basement provides the pneumatic air supply for the thermostats and control valves. These legacy pneumatic controls have far exceeded their life expectancy and provide very limited controllability. It is recommended that the temperature controls for the Station be completely upgraded to programmable direct-digital control (DDC) devices with a central building automation system.

Figure M1.15 Typical Pneumatic Thermostat

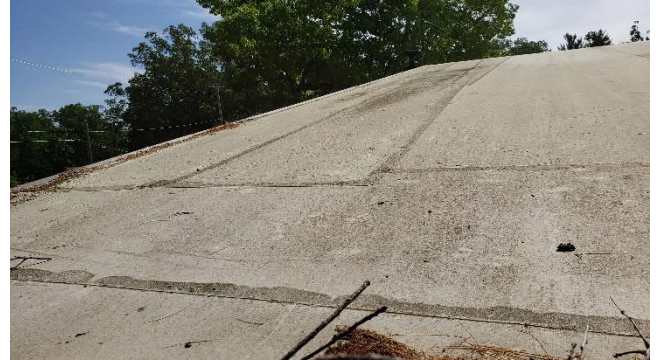
Figure A2.10

The 2-1/2:12 pitch roof consists of a white single ply membrane over rigid insulation of unknown depth and R-value, but appears to be older with the scrim (reinforcing mesh) reading through the membrane and along most of seams (Figure A2.10). The flashings around roof penetrations look to be in good condition with no known leaking problems. There was a build-up of pine needles along the west roof eave caused by the raised metal roof edges that make a 1" high dam (Figure A2.11). There are no gutters and downspouts to control water runoff, so rain sheet drains over the edges. We would recommend taking roof cores to evaluate the roof insulation condition and R-value (unless known) and replacing the roof membrane.

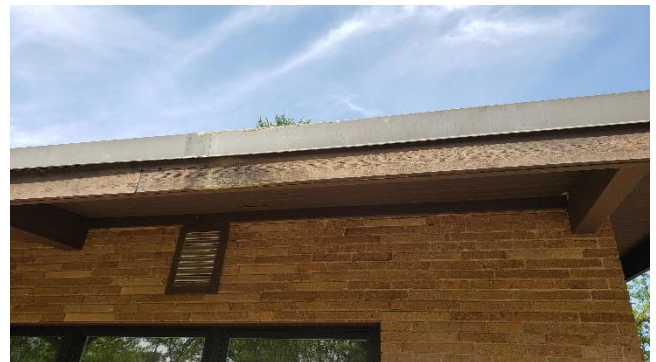
Figure A2.12

The metal eave and rake edges are in good condition and cover the top half of the wood eave and rake boards, however, the boards are cupping (Figure A2.12) and showing signs of wear and age. The exposed painted glued laminated beam extensions and tongue and groove roof deck boards soffits appear to be in good condition.

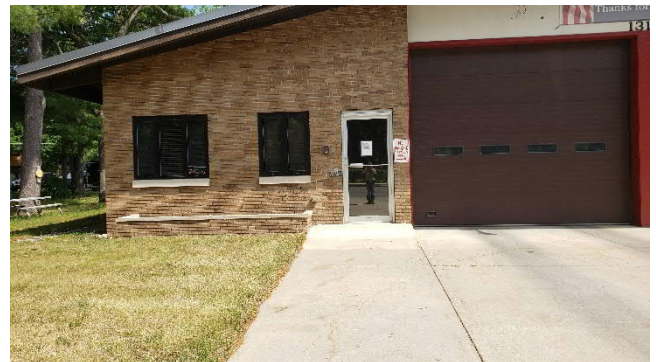
Figure A2.13

The all-masonry building is in good condition with no observed settlement cracks and some minor brick deterioration. The only concerns are the bases of the steel composite columns (Figure A2.13) at the apparatus bay overhead doors (all opening jambs and center column at south doors) show signs of rusting that need to be inspected and repaired. There are several original wall vents/louvers on the east and west walls that have been blocked and sealed from the inside.

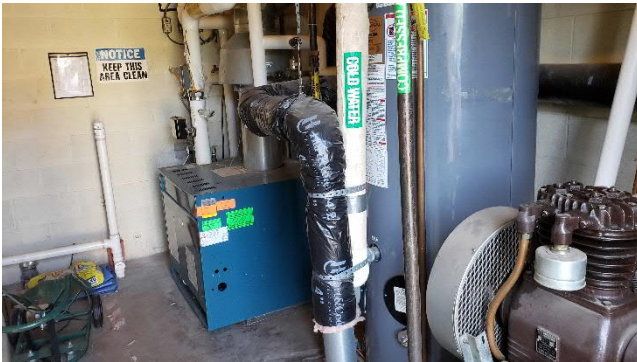
The existing heating system is that which was designed and installed as part of the building's original construction. The hydronic heating system is based on an atmospheric natural gas combustion, cast iron sectional boiler (the original unit was replaced in 2007) with a nominal output rating of 410,000 Btuh at 82% rated efficiency; providing heating hot water via pumped circulation hydronic distribution piping loops. Heat transfer equipment is primarily baseboard finned tube convectors located on the exterior walls of the occupied spaces, and ceiling-mounted vertical hot water unit heaters in the apparatus bay. A majority of the heating supply and return piping are located in pipe tunnels or below slab.

Figure M2.1 Existing Boiler

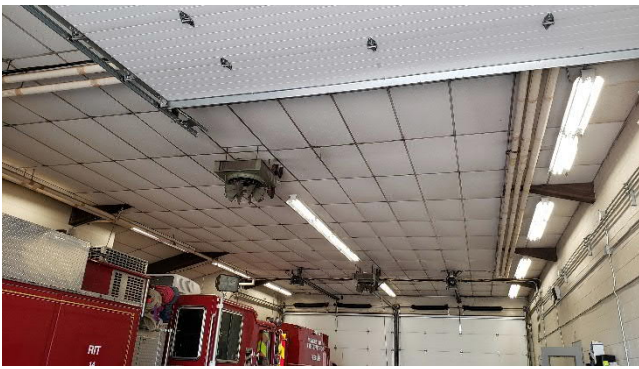
The Apparatus Bay currently has no vehicle exhaust detection and ventilation system. For the safety of building occupants, it is recommended that a new vehicle exhaust detection system be installed to monitor for unsafe levels of carbon monoxide and nitrogen dioxide. The system would include alarm devices as well as an exhaust fan to purge the bay with fresh air. It is also recommended that some form of exhaust capture equipment be added to the Apparatus Bay to minimize the accumulation of exhaust gases. Common capture systems include AirVac911 suspended units or PlymoVent snorkel units.

Figure M2.11 Apparatus Bay (no gas detection or exhaust system)

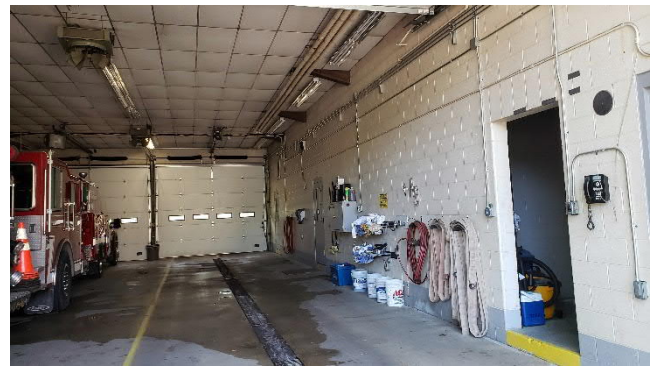
Figure M2.12 Apparatus Bay (no vehicle exhaust capture)
