BOARDMAN RIVER WALL STABILIZATION MEMORANDUM OF FINDINGS

City of Traverse City and Traverse City DDA
April 12, 2021

PROJECT BACKGROUND

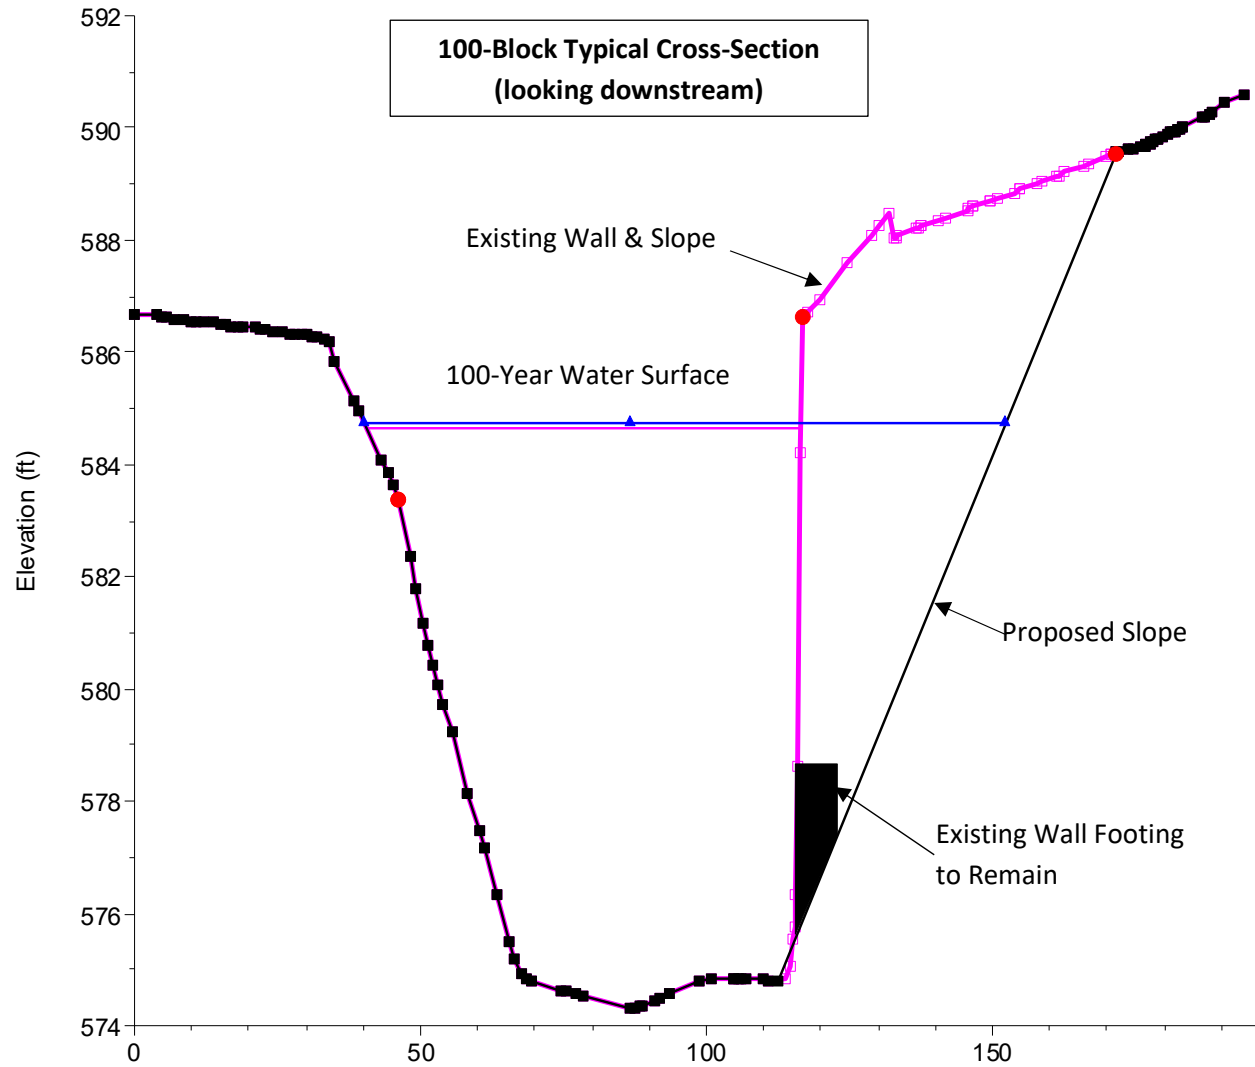
A typical cross-section from the 100 Block is presented below. This example utilizes a 4:1 side slope and extends the toe of the slope 3 feet in front of the retaining wall foundation.

SmithGroup recommends the removal of the wall on the 100 block. Removing the existing retaining wall allows for a natural shoreline and restoration of habitat along the riverfront. The existing stem of the wall would be removed with the existing footing and timber piles to remain. Riprap would be placed along the river bottom and up the shoreline to protect the shoreline from erosion and scouring while creating habitat for fish and other aquatic and riparian wildlife. Plantings, trees, grasses, and other landscape items will be added to protect the new bank from erosion and promote habitat.

We recommend removing only the vertical stem of the existing concrete wall, leaving the horizontal footing of the old wall in place as a shelter habitat for fish. Methods of creating a stable, scour resistant toe of the slope near the wall foundation will require further consideration during final design.

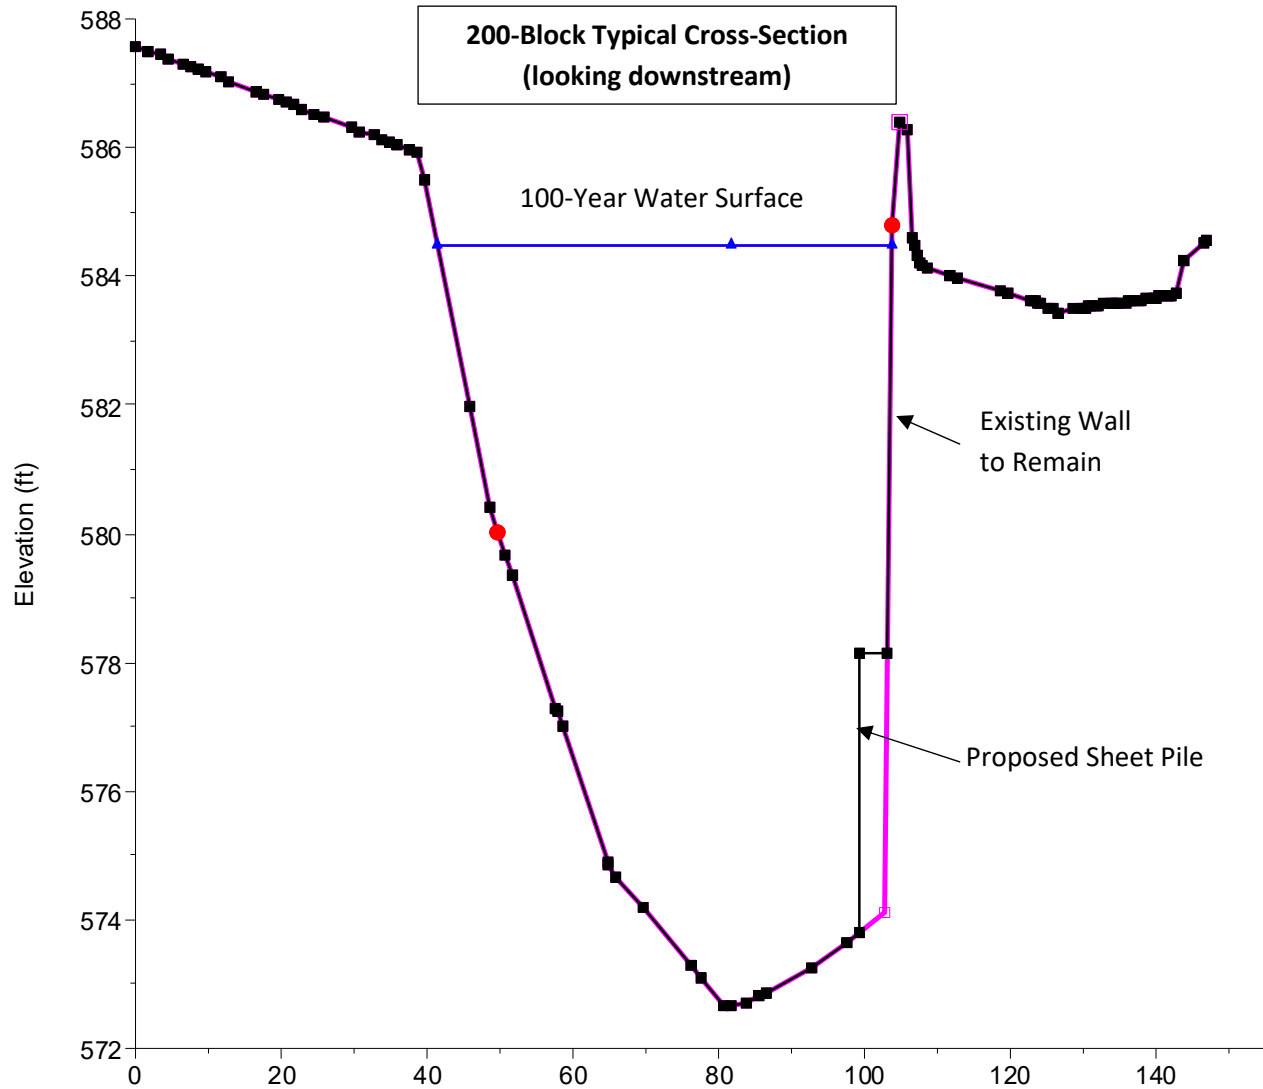
A typical cross-section of the 200 Block is presented below. The sheet pile extends up to the base of the wall and slightly constricts the channel.

SmithGroup recommends installing a sheet pile wall on the river side of the wall in the 200 block. A sheet pile wall would be driven into the earth on the river side of the retaining wall. The top of the sheet pile would coincide with the top of the wall footing. Once the sheet pile is driven into the river bottom, concrete would be pumped between the sheet pile and the existing retaining wall and fill under the existing footer as well to completely fill the gap. The sheet pile would protect the wall from further scour. Rip rap could be placed into the river bottom to provide some fisheries habitat benefit.

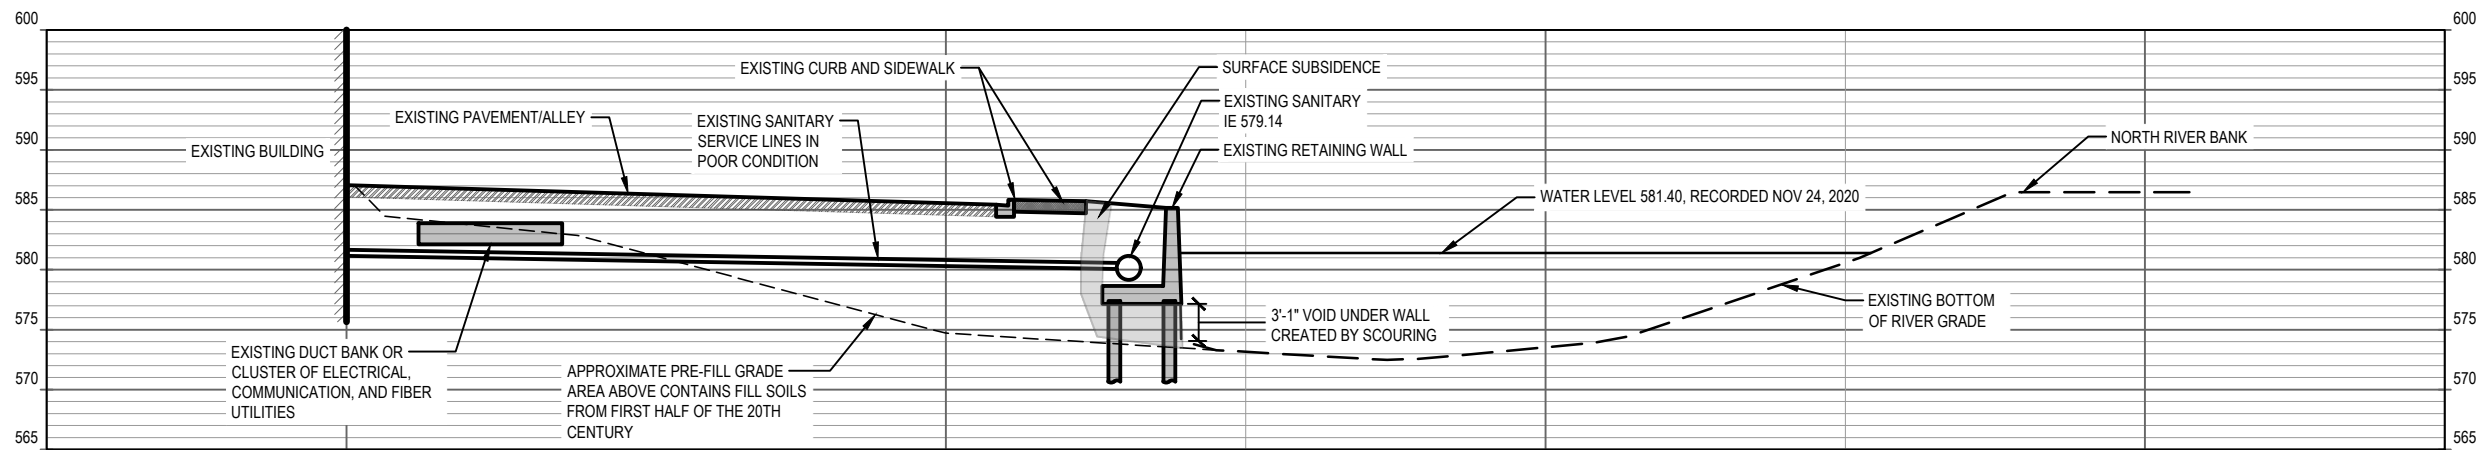
1 EXISTING CROSS SECTION - 100 BLOCK

The inspection also found that the subsidence and settling along the back side of the wall is due to a loss of soil material within the backfill of the wall, specifically within a zone of 10 feet +/- behind (south) of the wall. These soils are being lost due to scouring and undermining of the retaining wall footing. The material loss is exacerbated by high water levels of the Great Lakes and connecting channels which causes soil saturation, loss of consolidation of the backfill soils, and loss of the soils through gaps below the footing and through the walls at penetrations.
