**Operations Management and Facilities Services
2017-2018 Annual Report**

Traverse City, Michigan Regional Wastewater Treatment Plant

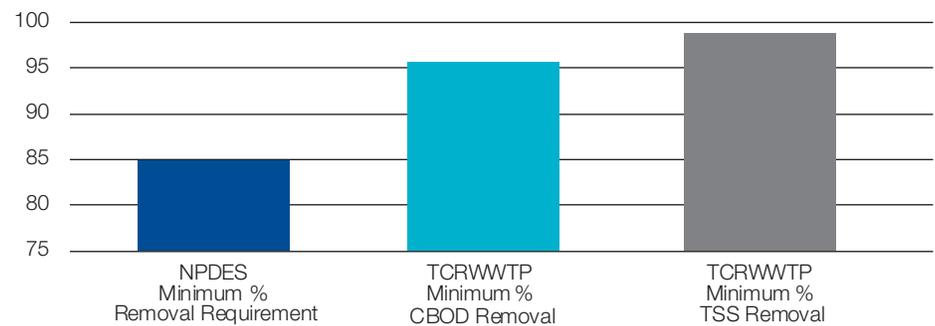
Exhibit 2

The plant is required to remove, at a minimum, 85 percent of the influent carbonaceous biochemical oxygen demand (CBOD) and total suspended solids (TSS). Exhibits 1 and 2, illustrate the plant's minimum percent removals for 2017-2018. Exhibit 3, contains NPDES permit effluent concentration [milligrams per liter (mg/L)] limits compared to the effluent maximum monthly average concentrations for 2017-2018.

2017-2018 TCRWWTP Percent Removals versus NPDES Permit Requirement

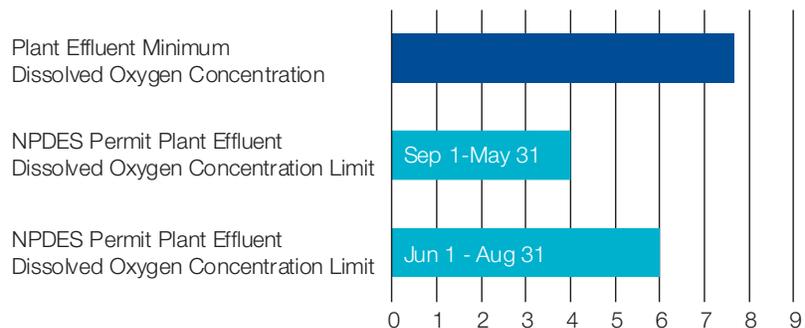
An adequate dissolved oxygen concentration and pH level is essential to maintaining the quality of a body of water. For this reason, the MDEQ included a minimum dissolved oxygen concentration (mg/L), and pH limits in the plant's NPDES permit. Exhibit 5 compares the plant effluent minimum dissolved oxygen concentration in 2017-2018 with the minimum dissolved oxygen concentration required in the NPDES permit. Exhibit 6 compares the NPDES permit pH limits with the maximum and minimum pH values for the plant's effluent in 2017-2018.

Plant Effluent Minimum Dissolved Oxygen Concentration versus NPDES Permit Requirement

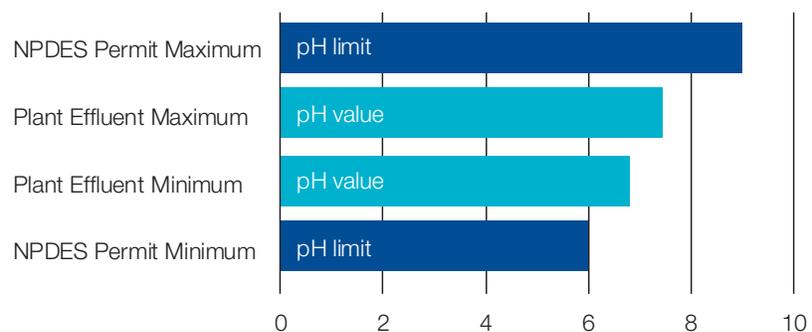
Exhibit 6

2017-2018 Plant Effluent Maximum and Minimum pH Values versus NPDES Permit Limits

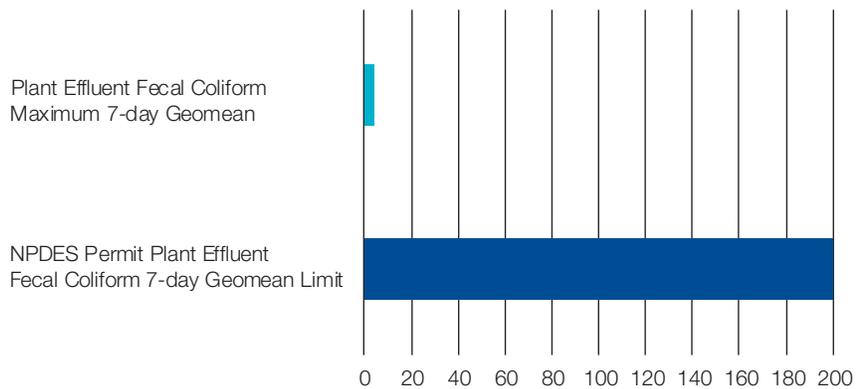
To protect the City's water ways and ultimately the public from harmful pathogens that are present in wastewater, the MDEQ requires disinfection of WWTP effluent. Disinfection destroys or deactivates pathogenic microorganisms resulting in the termination of their growth and reproduction. The plant's NPDES permit limits the monthly geomean for fecal coliform to 200 counts (cts)/100 milliliters (mls). Exhibit 7 compares the NPDES permit effluent requirement with the plant effluent maximum 7-day geomean for 2017-2018.

2017-2018 Plant Effluent Maximum 7-day Geomean versus NPDES Permit Effluent Requirement

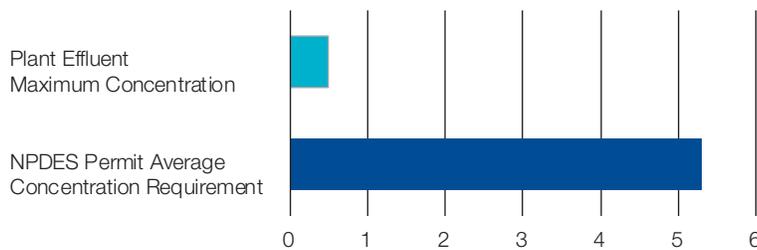
Silver, among other uses, is a byproduct of traditional photography found in photo fixer. While the effects of silver in the environment vary greatly based on the form of silver, it can be toxic to both plants and animals. In order to protect the aquatic life in the receiving stream, the Boardman River, the NPDES permit limits the amount of silver allowed in the plant effluent to a concentration of 5.3 ug/L. Exhibit 8 compares the NPDES plant effluent silver concentration limit to the actual plant effluent maximum silver concentration for 2017-2018.

2017-2018 Plant Effluent Maximum Silver Concentration versus NPDES Permit Silver Concentration Requirement

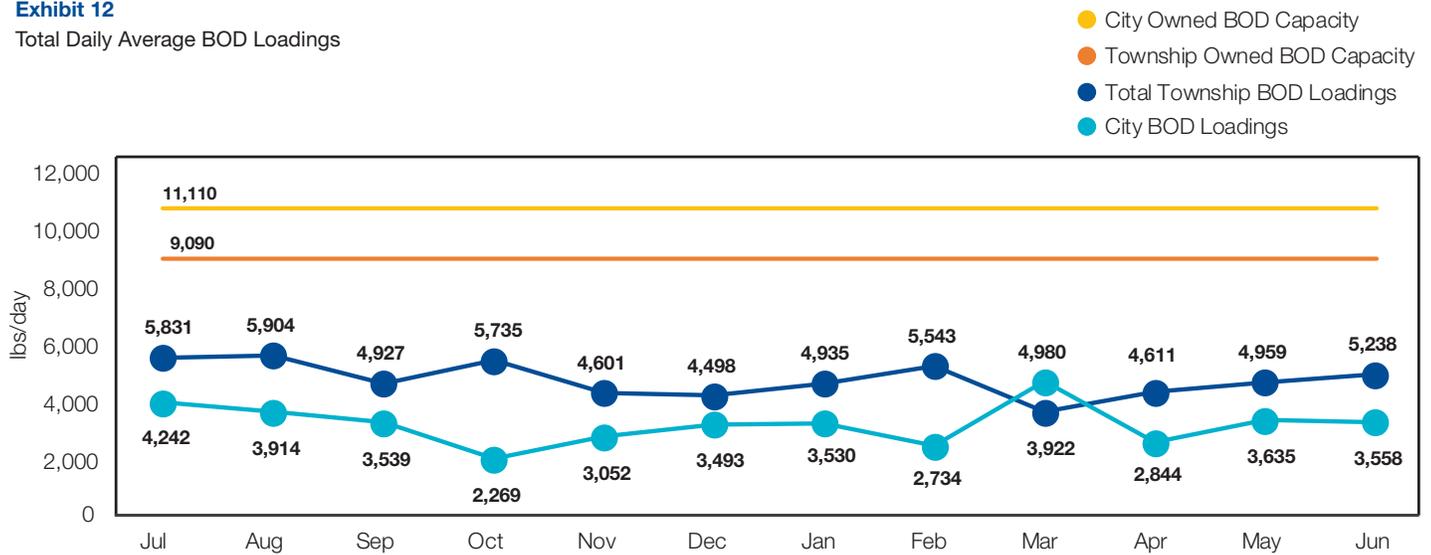
Exhibit 12

As part of Jacobs' contractual obligation to the City, we operate and maintain eight automatic flow proportioned samplers strategically placed throughout the collection system, in order to obtain representative samples from each of the following townships: Garfield, East Bay, Acme, Elmwood, and Peninsula. We collect three samples per week, and each sample is analyzed to determine its biochemical oxygen demand (BOD) concentration. These concentrations are used to calculate a monthly average BOD concentration. The monthly average BOD concentration for each township and monthly township flow values (provided by the City and the County) are used to calculate the BOD loadings from each of the fore mentioned townships, and the City. Together the five Townships own 45 percent of the facility's organic loading capacity amounting to 9,090 pounds per day of BOD. The City owns the remaining 55 percent of the facility's organic loading capacity or 11,110 pounds per day of BOD. (Exhibit 12 summarizes the 2017-2018 BOD loadings versus owned capacities.)

Total Daily Average BOD Loadings

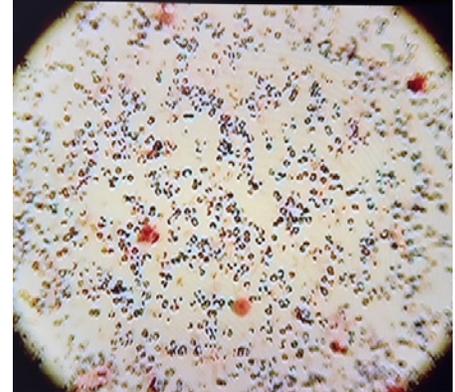
Jacobs identified CSGPB in the biomass of the treatment plant and linked it to a decline in membrane train permeability in 2011. Despite our best efforts, we have been unsuccessful in preventing their periodic growth in the system. In 2016, Jacobs funded a studied, currently being conducted by the University of Michigan (Graduate student Avery Carlson, and Dr. Glen Daigger). In 2017-2018, the University isolated and identified the CSGPB to the genus level as *Staphylococcus* using a highly specialized probe that would only highlight this genus. Then through Metagenomics, the study of genetic material recovered directly from environmental samples in this case samples for the biomass at the WWTP, the University showed that the biomass during a CSGPB outbreak was statistically different from that during "normal" operations. The Metagenomics showed that the Firmicutes phylum, which the *Staphylococcus* genus is a part of, is in higher abundance during the outbreaks than during "normal" periods. This information confirmed that *Staphylococcus* Bacterium would be a good indicator of the presence of problematic characteristics in the aeration basin mixed liquor, which is comprised of the biomass and the waste stream entering the facility's aeration basin. The question then/now was/is, what are the problematic characteristics of the mixed liquor that lead to an outbreak of this indicator organism? To date, the University's hypothesis is that an ion imbalance in the mixed liquor may be causing the outbreak of the *Staphylococcus* bacterium and may be what is the root cause of the permeability issues at the facility. Currently, we are working with the University of Michigan's Dr. Daigger and Avery Carlson, to pinpoint the causality of the facility's permeability issues, and possible solutions.

CSGPB.

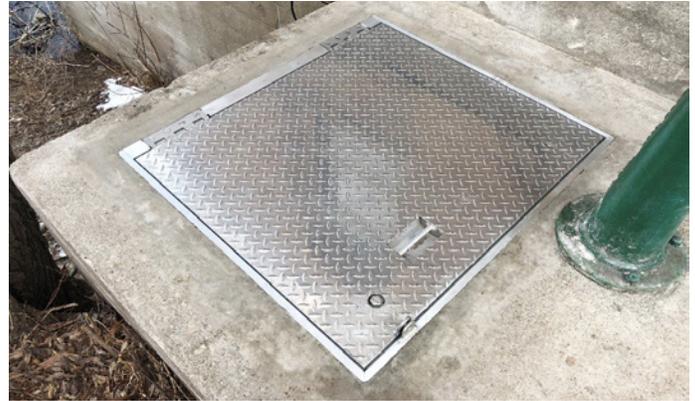
Top view of new Front Street hatch.

We purchased and installed a new odor canister for the vent stack at the Front Street lift station. We created a preventive maintenance (PM) work order (WO) for changing the carbon in the canister on a quarterly basis. In addition, when the hatch had to be replaced at the Front Street lift station, we facilitated the installation of a gas tight hatch with safety netting for fall protection.

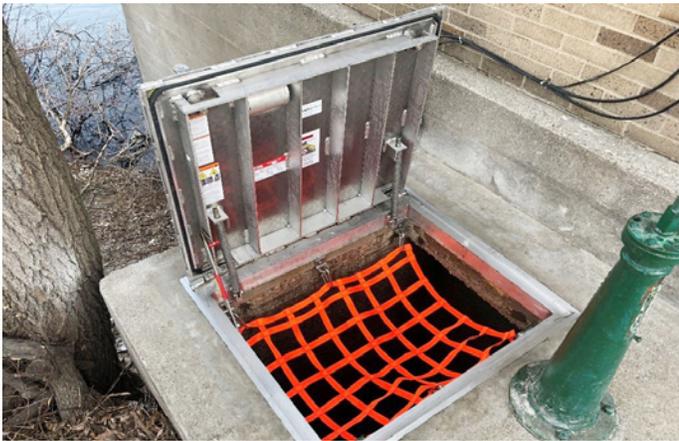
New Front Street hatch with safety netting.

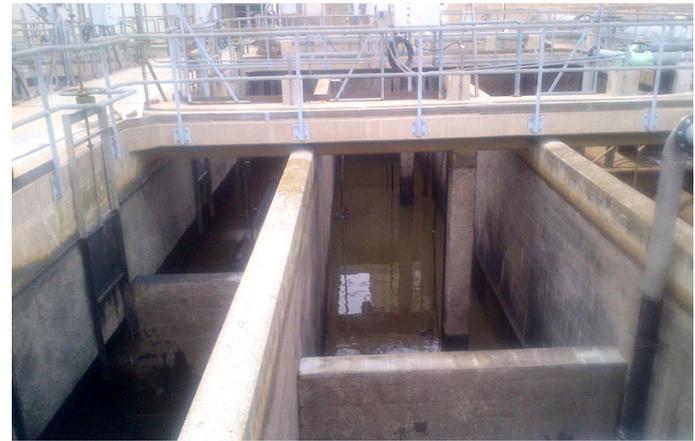
North basin being taken out of service for cleaning and maintenance.

To optimize the efficiency of the aeration system in the aeration basin, as well as, to optimize the detention time of the waste stream in the basin, we took the north aeration basin out of service to clean the aeration grid diffusers, make the necessary repairs to the system, and remove any grit that had built up in the basin. This task is performed on one side of the basin or the other every year.

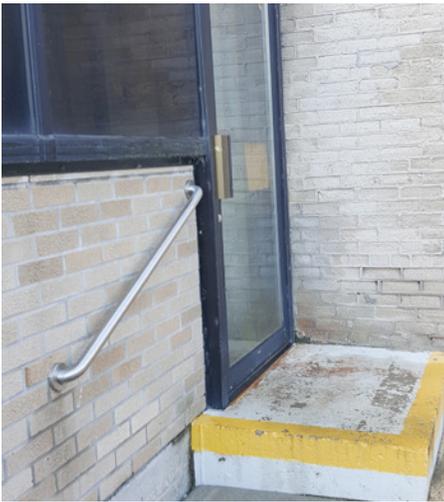
Door to primary deck.

Jacobs installed railings on the stairs to the primary clarifier decks to reduce the likelihood of falls.

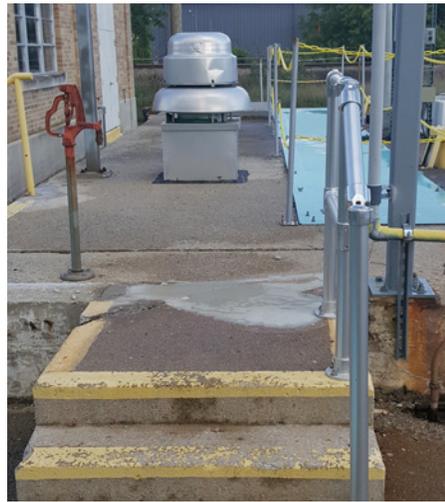
Stairs between the primary decks.

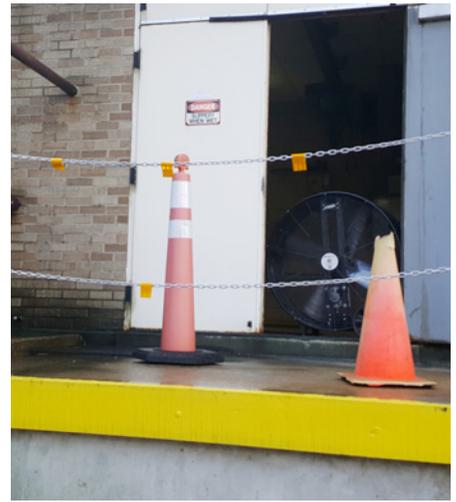
Fall protection installed on the north loading dock.

We installed fall protection on the north loading dock.

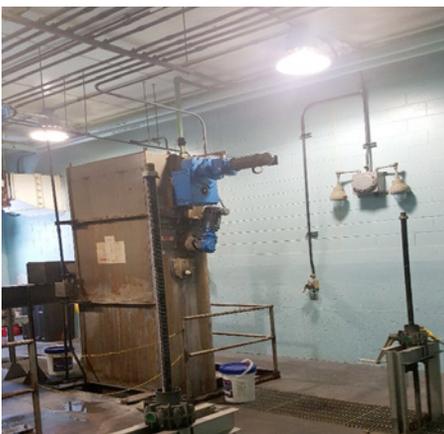
East fine screen building LED light replacement.

We installed LED lighting in the fine screen building.

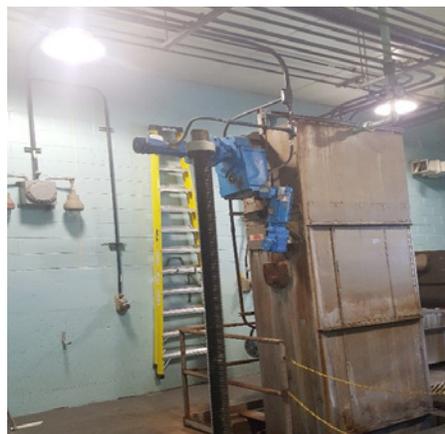
West fine screen building LED light replacement.

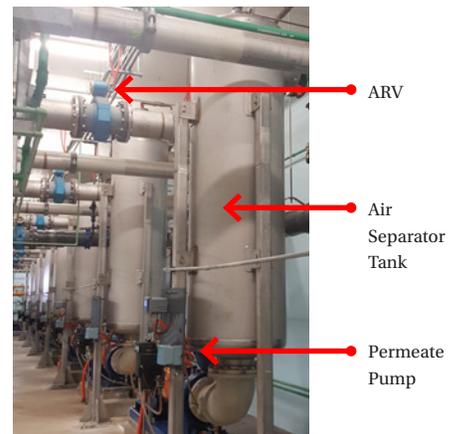
We inspected all air relief valves (ARVs) on the membrane system. They were found to be in good working order. The proper operation of the ARVs is vital to the ability to filter water which is why Jacobs performs this inspection proactively on an annual basis and stores a spare ARV in our equipment inventory.

ARVs on the membrane permeate pump air separator tank.

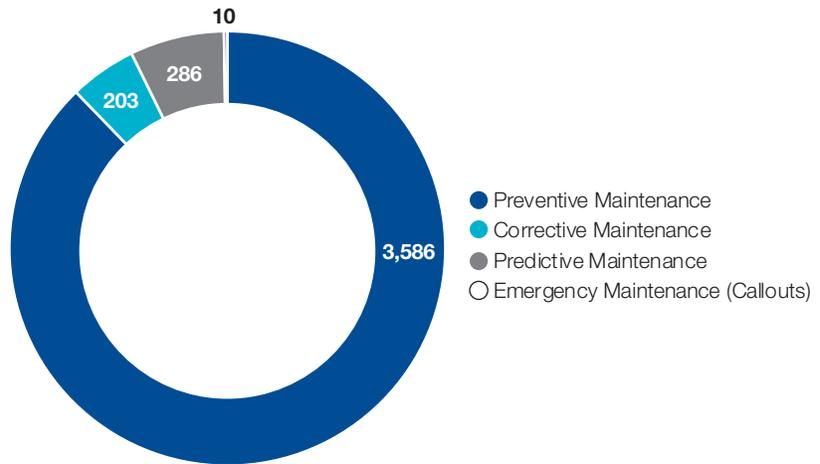
Exhibit 13
Completed Maintenance Work Orders

Jacobs performed 4,085 WOs in 2017-2018. Ninety-five percent of the WOs were proactive in nature falling under the category of PM activities or predictive maintenance (PDM) activities. Jacobs maintenance program is centered around equipment capacity assurance through proper asset management, a focus that prolongs the life expectancy of the City's assets, minimizes the likelihood of compliance issues related to asset failures, reduces safety vulnerabilities, optimizes staff labor hours, and curtails the cost of repairs with the use of proper planning and scheduling. Our proactively robust maintenance program is geared toward decreasing the need for emergency and corrective maintenance (CM) repairs, which accounted for only 5 percent of our maintenance WOs in 2017-2018. Exhibit 13 highlights our maintenance WO activity through the last year.

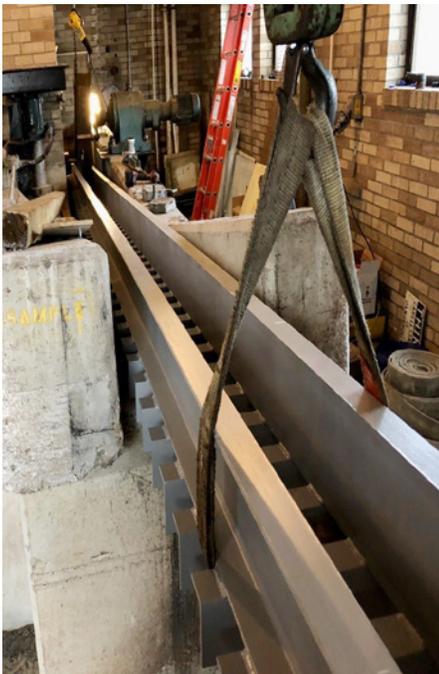
East rake arm replacement.

We repaired the classifier arm for the east grit chamber. A new classifier arm, from the sole-source distributor, was quoted to cost \$9,180. We fabricated and coated a classifier arm for \$3,500, saving \$5,680.

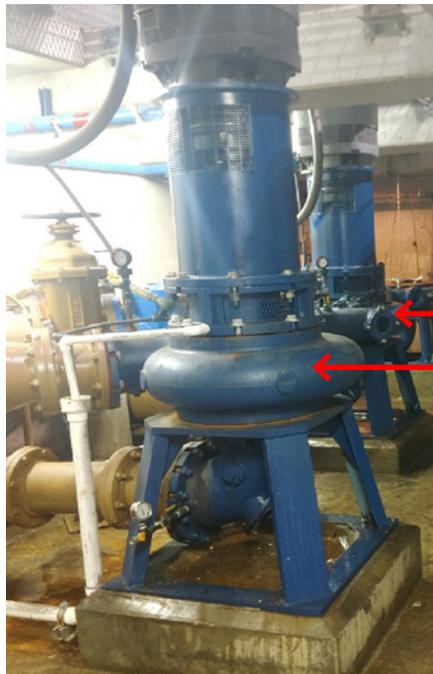
Front Street lift station pumps 2 and 3 refurbished.

- Pump 3- new rotating assembly installed.
- Pump 2- repaired rotating assembly installed.

The Front Street lift station was last upgraded over 18 years ago. In 2017-2018, we had planned for the refurbishing of the pumps, as well as, the upgrade of the programmable logic controls (PLCs). With the City Commission's approval, Jacobs purchased and installed a new rotating assembly in pump 3, however, the pump was not keeping up with the flow demand. While we were troubleshooting the cause of pump 3's capacity limitations, pump 2 failed. This left pump 4 as the only fully operational pump, as pump 1 was decommissioned after the last upgrade, and eliminated the lift station's operational redundancy and reliability. Jacobs initiated the emergency response plan(ERP) we created for such scenarios. We modified the discharge line for pump 1 so that a pump around pump could be used at the lift station to keep up with the flow demand, commissioned the setup of a pump around pump at the station, and expedited the repairs for pumps 2 and 4; all was completed with the support of the City Commission. With the pump around pump in place, Jacobs regained the full capacity of pump 3 and repaired pump 2. When pump 2 and 3 were back in service at full capacity the pump around pump was decommissioned. While we were onsite monitoring the pump around pump at the lift station, we painted the pumps, piping, and handrails; replaced and painted the inside wet well cover; installed new gauges on the pumps' discharge lines; installed guards around the pump shafts; and installed LED lighting.

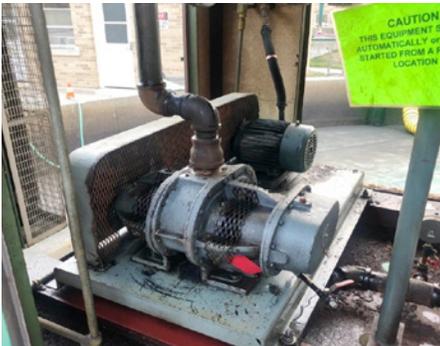
Old gas compressor and motor.

We replaced the gas compressor, motor, gas line, and isolation valves for digester #4.

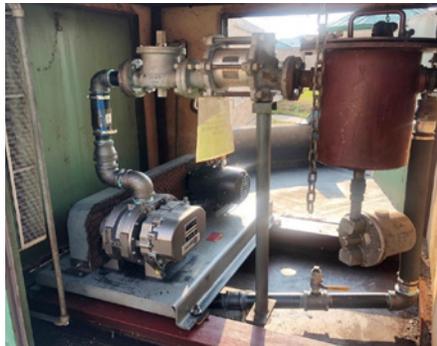
New gas compressor and motor.

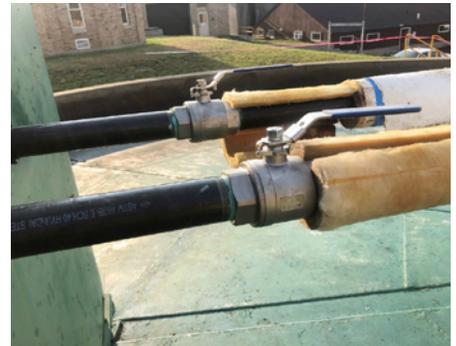
New gas line isolation valves.

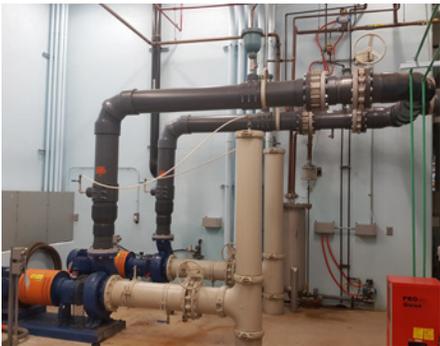
New schedule 80 PVC discharge piping for the membrane back pulse pumps.

We facilitated the replacement of the ductile iron discharge piping for the membrane system back pulse pumps with new schedule 80 PVC piping.

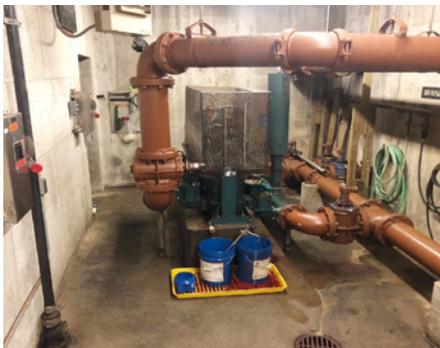
Old piston pump without VFD.

The west biosolids storage tank pump replacement project was completed. This project was included in the City's capital improvement plan (CIP) as CIP# 894. The piston pump from 1985 was replaced with two new progressive cavity pumps equipped with variable frequency drives (VFDs) for energy efficiency. Also, added in this project were level transducers for each storage tank that were integrated into the supervisory control and data acquisition (SCADA) for better alarming and monitoring capabilities.

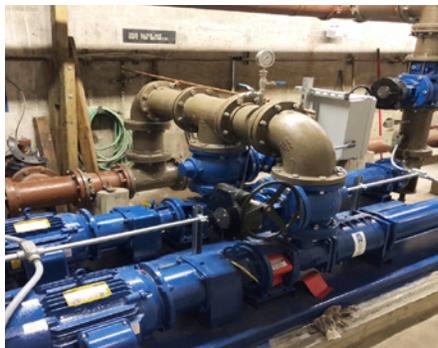
New progressive cavity pumps with VFDs for energy efficiency.

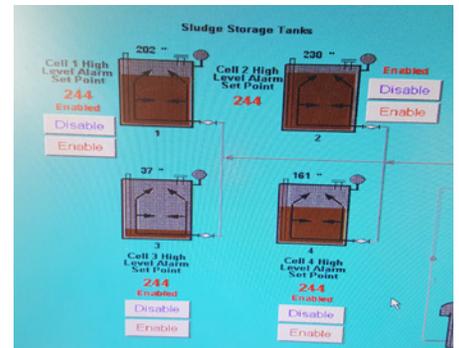
SCADA integration of new level transducer measurements.

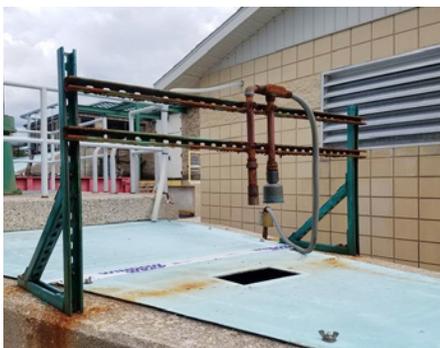
Old flow measuring device.

We upgraded the plant influent and primary effluent flow measuring devices. The flow measuring devices were showing signs of failure and were no longer readily supported. Measuring the influent flow accurately is required by the facility's NPDES permit, and most of the membrane programming is tied into the primary effluent or plant influent flow measurements, so both are imperative to the proper operation of the facility's secondary treatment process. The new flow measuring devices use radar technology to measure flow. This technology is more reliable, highly accurate, and is well supported.

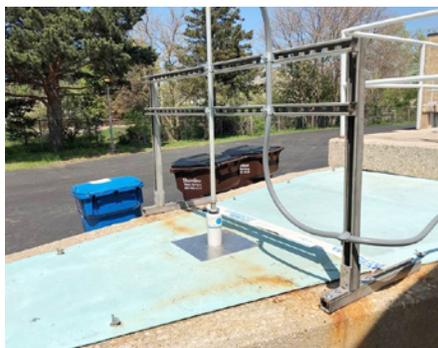
New flow measuring device.

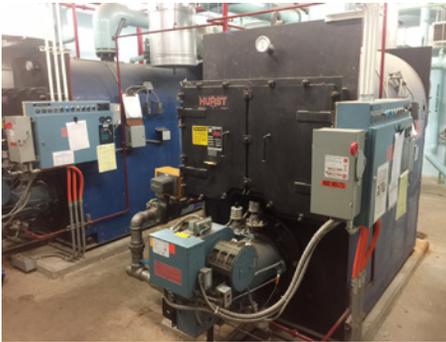
Facility boilers.

The boilers, used to burn methane gas produced by the digesters to heat water that maintains the temperatures of the digesters and the administration building at the facility, were overhauled.

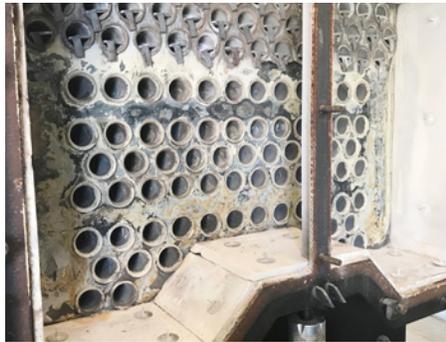
Inside the boiler heat exchange.

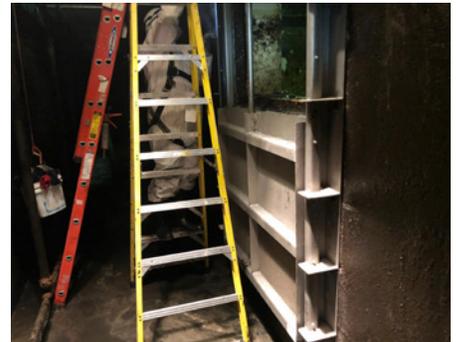
New stainless steel gate installed.

We completed the replacement of four of the aluminum gates on the membrane trains with four new stainless-steel gates. This project is in the City's CIP as #786. Twelve of the 16 aluminum gates on the membrane system have now been replaced.

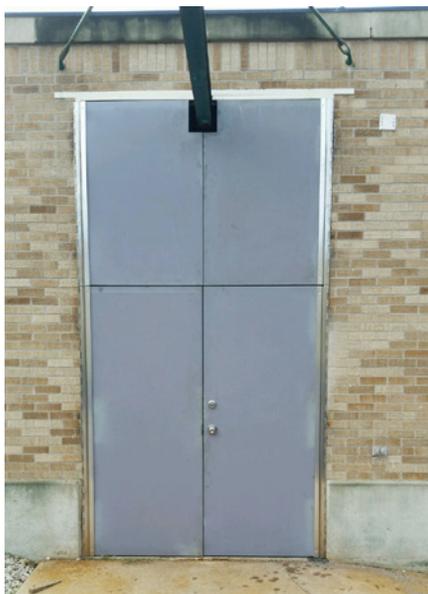
New door on east grit chamber.

We replaced the east grit chamber doors.

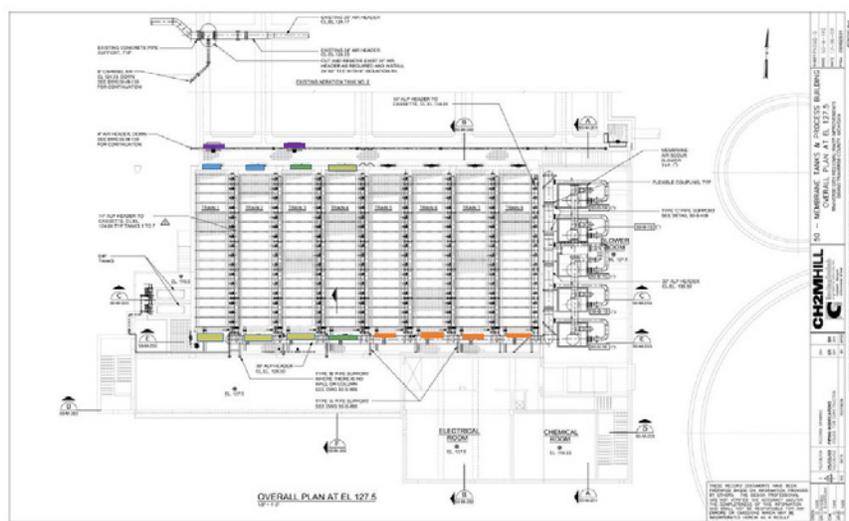
Membrane gate replacement map.
