# Traverse City Regional Wastewater Treatment Plant

## Overview of Equipment and Last Installation/Upgrade

# 2018-2019 Capital Improvements

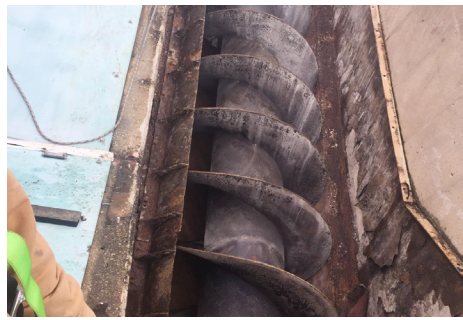
**2C** **Screw Pump Replacement (CIP #893)** The 3 Screw Pumps were installed in 1976. Screw Pump #1 has been replaced and the trough and wet well have been reconditioned. The replacement of Screw Pump #2 and #3 is scheduled for 2019-2020. The facility plan will include the upgrade of these to screw pumps for the purpose of evaluating the condition of the concrete troughs and wet wells, and examining alternative technologies.

Before upgrade. Out of service because screw body was cracked.

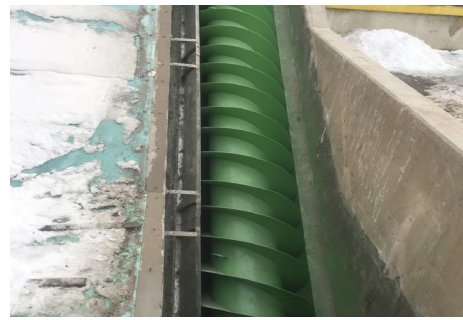
New screw body and trough reconditioned.

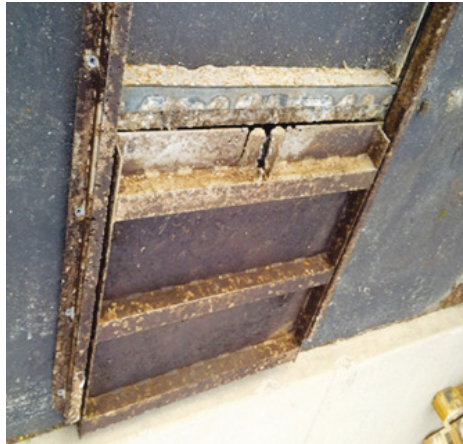
**4** **Membrane Gate Replacement (CIP #786)** The Membrane gates were installed in 2004. At that time, it was standard practice to install Aluminum gates for Membrane trains. The Aluminum gates have not held up, and have failed or are nearing failure. We have replaced 8 of the 16 membrane gates that needed replacing with stainless steel gates and have 8 gates left to replace. The replacement of 4 Membrane Gates is in the CIP for 2017-2018 and 2018-2019.

Old aluminum gate.

**4** **Membrane Gate Replacement. (CIP #786)** Estimated cost \$59,982.

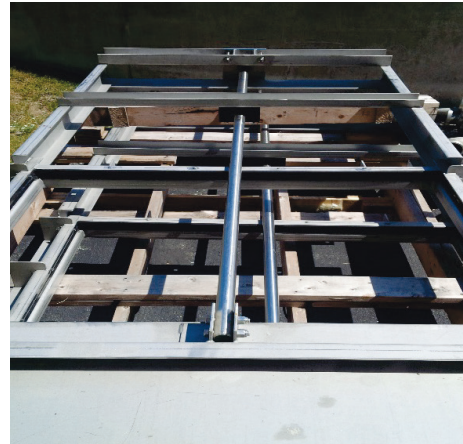
New stainless steel gates.

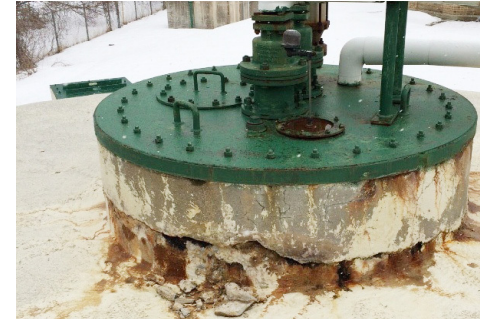
**1** **(CIP #948 and #966)** Digester #3 and #4 were put into service in 1959 - They are in need of a condition assessment to identify areas needing reconditioning. Digester #3 (currently out of service as a result of cracks in cap, cover and manhole excess points) had a condition assessment performed in 2017. The related reconditioning of Digester #3 is in the CIP for 2018-2019. The condition assessment for Digester #4 is included in the Engineering Study pertaining to the Facility Plan (CIP #1019).

Digester #3 -cracked cap.

**1**  
**Digester #3 Reconditioning. (CIP #948)**  
Estimated cost: \$608,188.

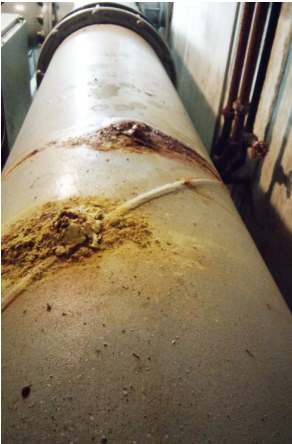
**2A** **The engineering study, CIP #1019** (That pertains to the facility plan), will serve as a plan of action on how best to address the needs of the aging portions of the facility. There are portions of the facility that were originally constructed in the 1930s, 1950s, 1970s, and 1980s. These portions of the facility are showing signs of failure or have failed. The pictures below illustrate a couple of these areas.

Primary header installed in 1976.

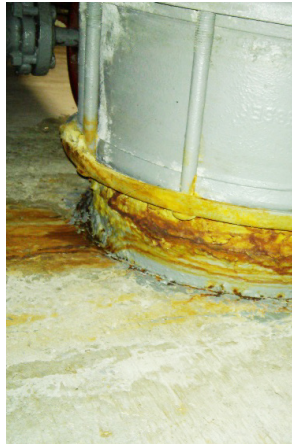
Primary header.

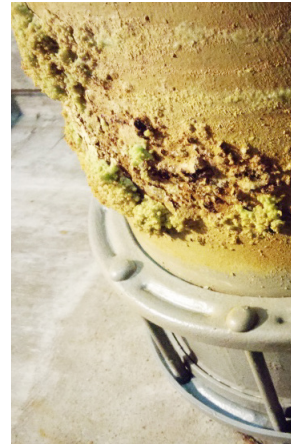
Primary header.
