2023 Infrastructure Evaluation And Capital Improvement Plan

Grand Traverse Commons

For: Grand Traverse Commons Joint Planning Commission

October 9, 2023
GFA Job No. 22286
HRC Job No. 20220549

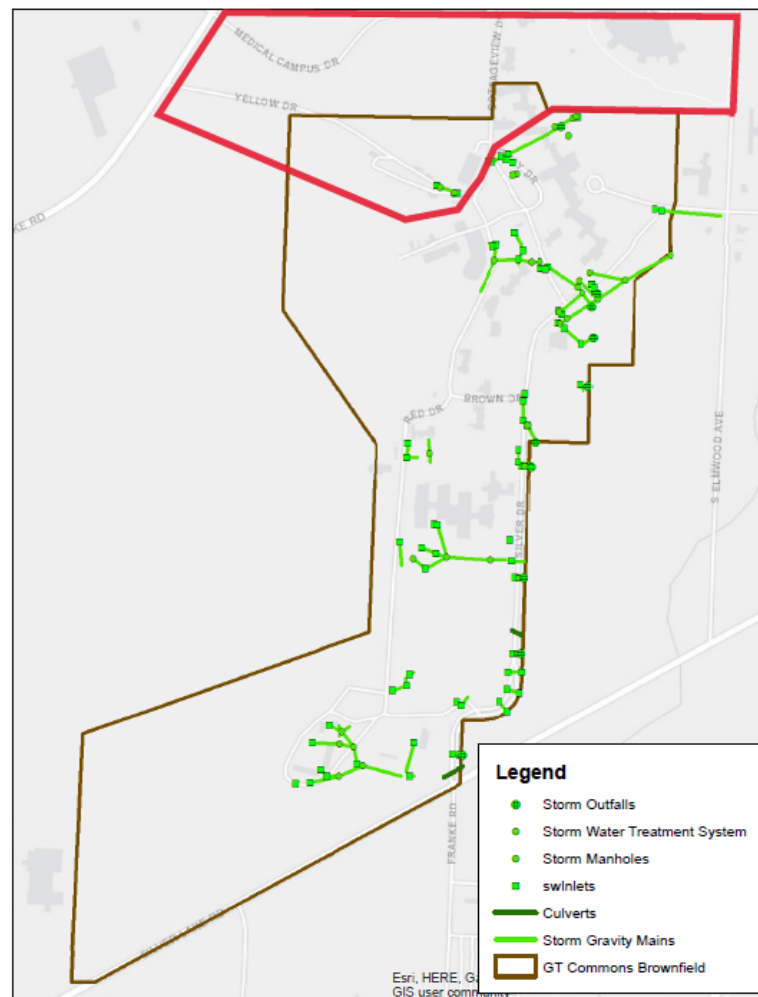
Figure 3.2 Grand Traverse Commons Drainage Area of Concern

impervious infrastructure including buildings, parking lots and motorizing and non-motorized infrastructure both contributing to and subject to impacts from both above and below ground water. The potential impacts from flooding, seepage and runoff to private property are extremely concerning which is currently managed by aged, undersized and ill maintained surface and subsurface stormwater infrastructure. This area should have a greater priority for capital improvement planning than other areas. This area is serviced by what is referred to as Tributary “AA” and is depicted below in Figure 3.2 in red.

Historical records and observations during heavy rain events have been documented with recent event of note occurring in 2020. The neighborhood surrounding the Munson Medical Center campus was particularly hard-hit by flooding due to the overflow of Kids Creek and other tributaries. Several areas of The Village at Grand Traverse Commons experience flooding as streams and other watersheds in the adjacent woodlands rushed downhill and converged on campus roads, funneling into a flood that poured down Red Drive in front of Left Foot Charley.

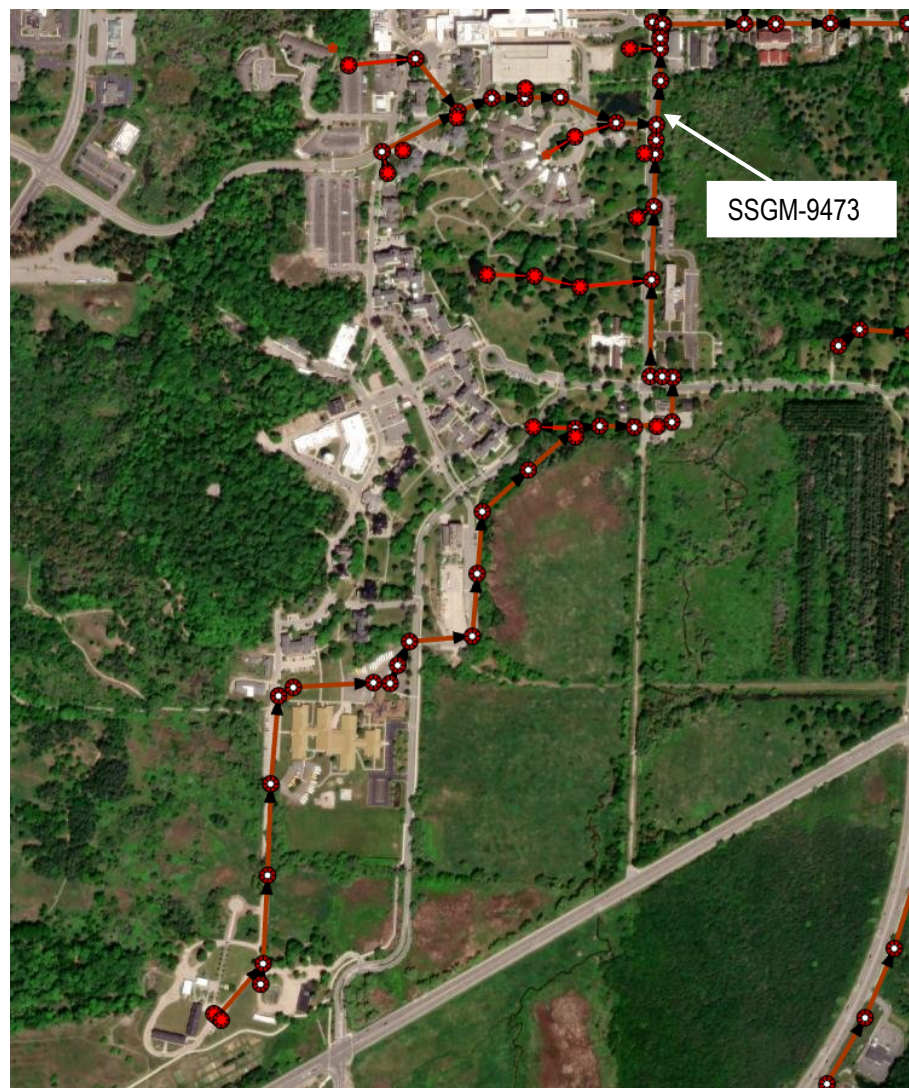
Figure 4.1 Location of Greatest Flooding Potential

Utilizing the City of Traverse City GIS and the GIS data acquired within this project the areas of greatest flooding were determined with respect to subsurface infrastructure. This evaluation did not account for above ground surface conveyance. This analysis accounted for pipe size, slope, and predicted flows. It was determined that the worst reach directly servicing the Grand Traverse Commons to be SSGM-9473. This pipe reach connects the manholes SSM-1683 and SSM-1648. Maximum flow through this portion of the system utilizing Manning's equation assuming full pipe gravity flow is 0.462 million gallons a day. **Figure 4.1** provides the location where conditions including slope, material, flow and pipe diameter provides greatest flooding potential within the system.

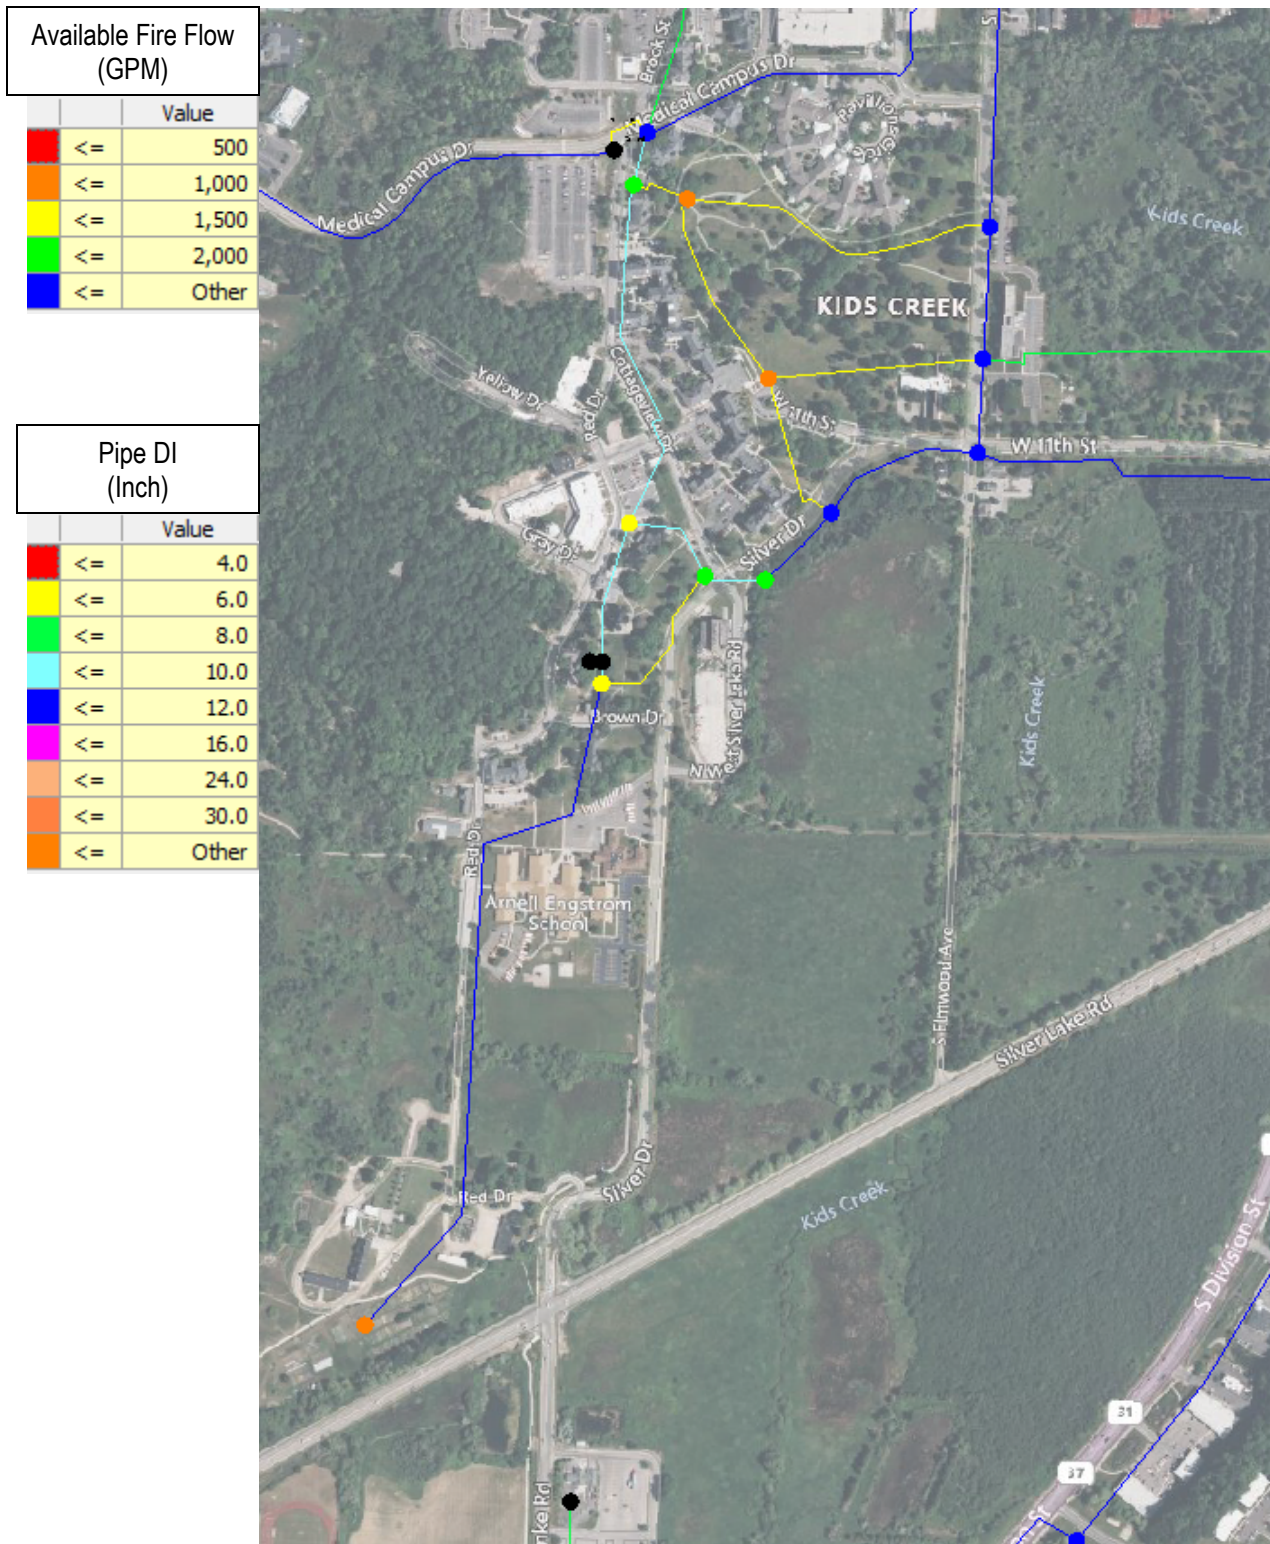
Appendix B-4 Existing Fire Flows

Most of the Grand Traverse Commons can be considered apartment buildings or commercial with fire suppression and the entirety of the system should allow for 1,500-gpm fire flow. Based on the fire flow modeling results, a majority of the system fails to meet the minimum recommended available fire flow. See appendix A-3 for results from model. Recent testing by AFP Specialties, Inc, of the interior fire pump within the historic barns located at the southern end of the Grand Traverse Commons provided results of 380 GPM fire flow at 10 psi. Documentation from Grand Traverse Metro Fire department cites the facility is not in compliance.

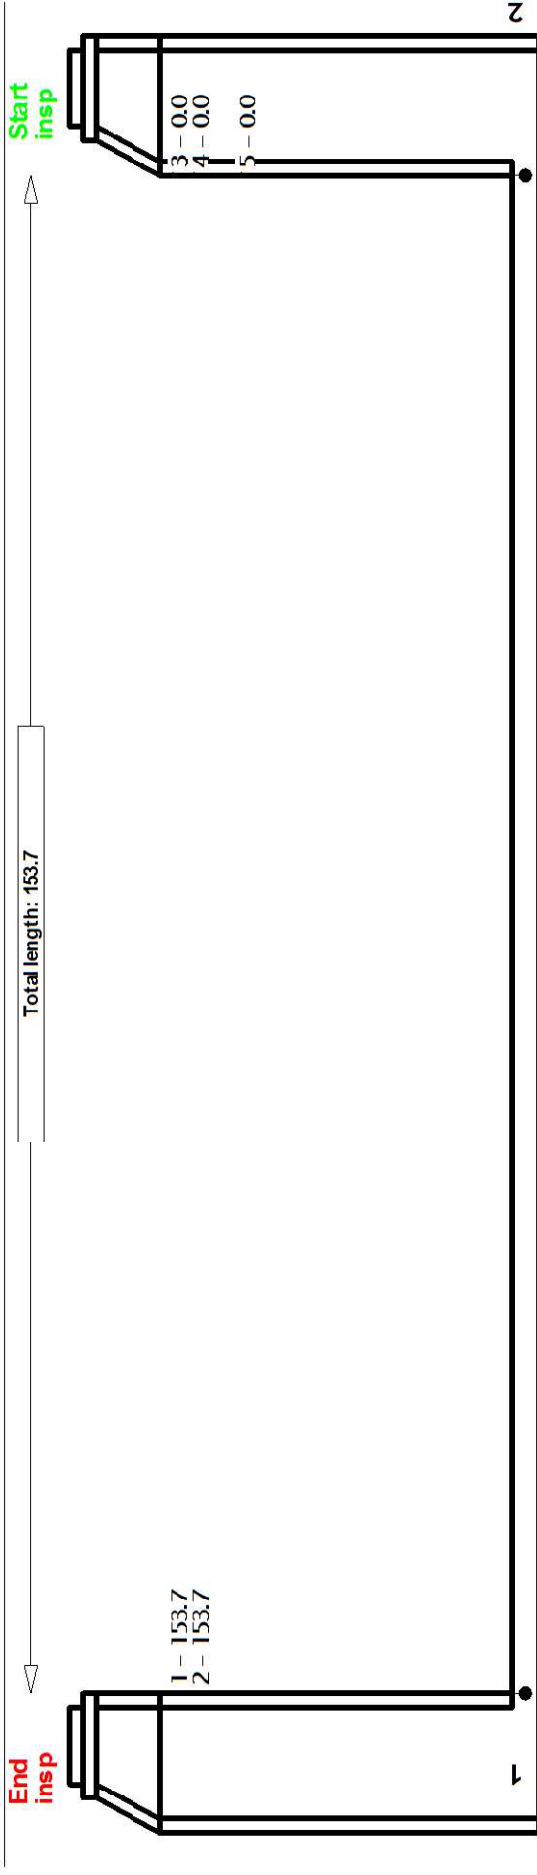
2 to 1
Upstream inspection

1 - 153.7 <Complete Inspection inspection> at 08:41:23
2 - 153.7 Manhole
Finishing manhole: 1
3 - 0.0 Miscellaneous Water Level 5.000%
4 - 0.0 Manhole
Starting manhole: 2
5 - 0.0 <Start inspection> at 08:35:57

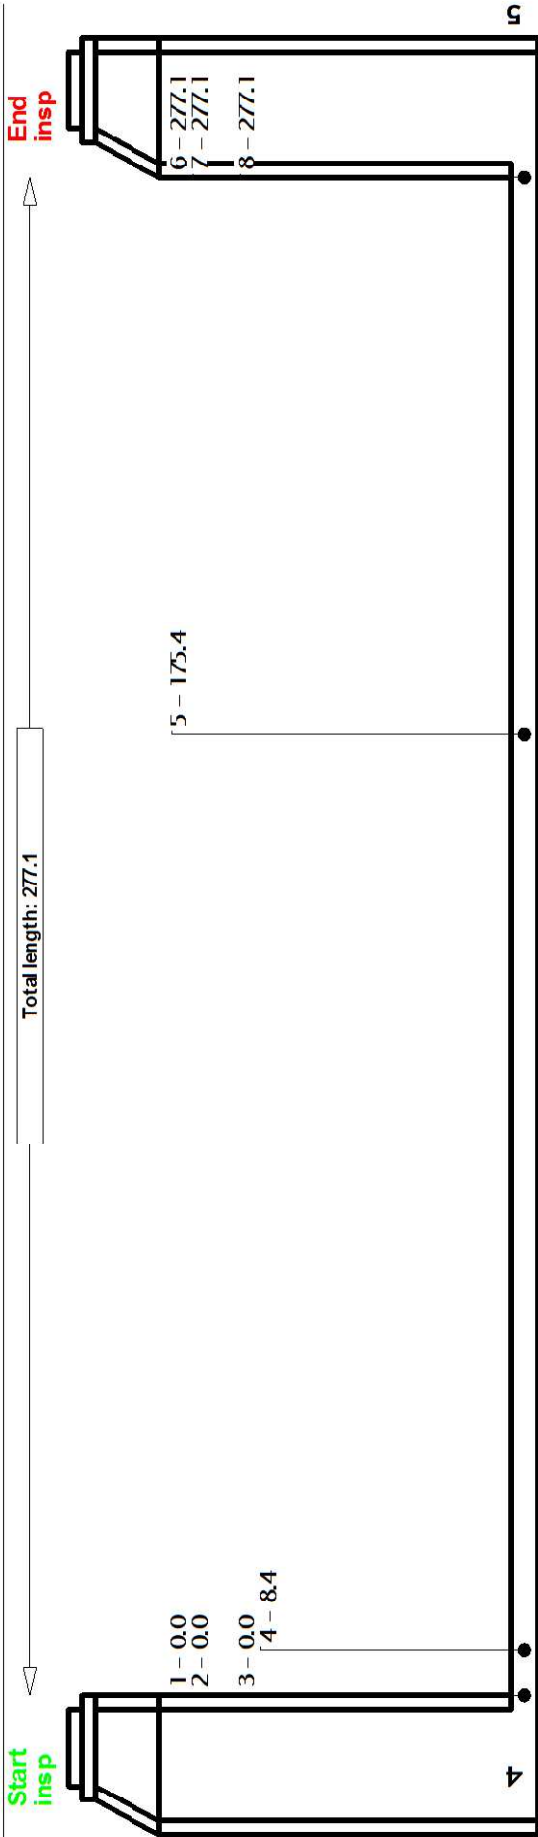
4 to 5
Downstream inspection

1 - 0.0 <Start inspection> at 10:29:56
2 - 0.0 Manhole
3 - 0.0 Miscellaneous Water Level 0.000%
Starting manhole: 4
4 - 8.4 Deposits Settled Hard/Compacted 25.000% At 4 To 8
5 - 175.4 Roots Tap Joint 5.000% At 9 At Jnt
6 - 277.1 Deposits Settled Hard/Compacted 25.000% At 4 To 8
7 - 277.1 Manhole
Finishing manhole: 5
8 - 277.1 <Complete inspection> at 10:40:57

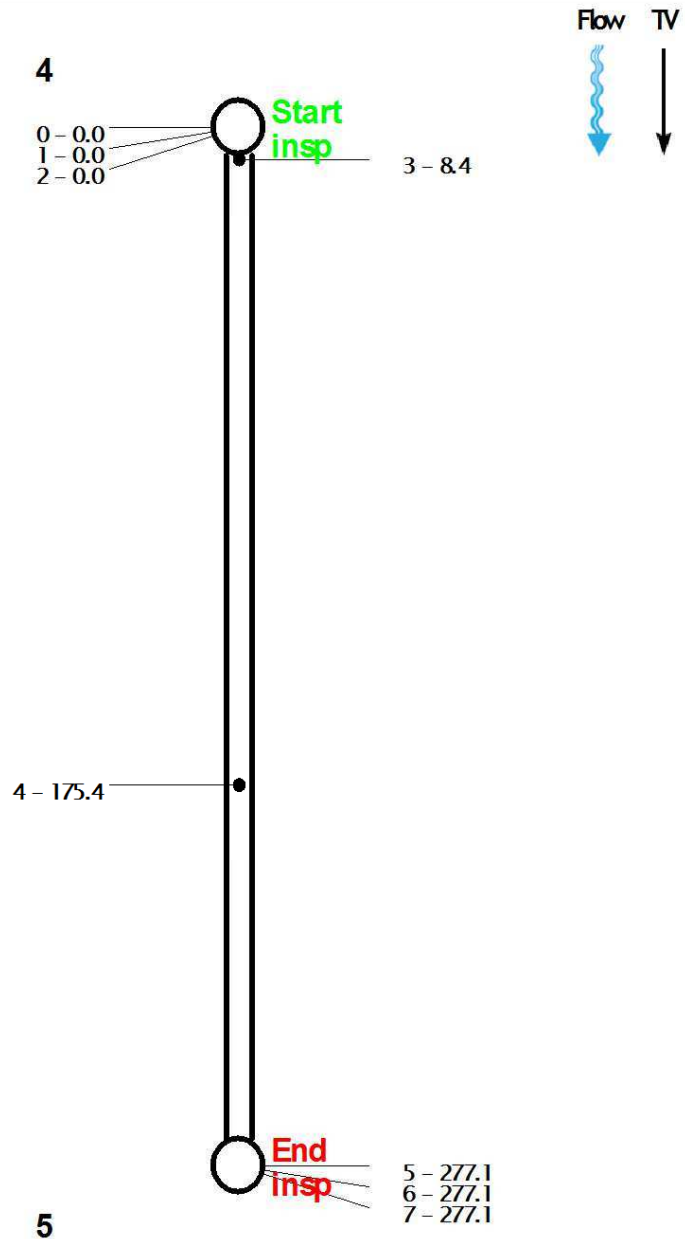
4 to 5

0 - 0.0 <Start inspection> at 10:29:56
 1 - 0.0 Manhole
 Starting manhole: 4
 2 - 0.0 Miscellaneous Water Level 0.000 %
 3 - 8.4 Deposits Settled Hard/Compacted 25.000 % A...
 4 - 175.4 Roots Tap Joint 5.000 % At 9 At Jnt
 5 - 277.1 Deposits Settled Hard/Compacted 25.000 %...
 6 - 277.1 Manhole
 Finishing manhole: 5
 7 - 277.1 <Complete Inspection inspection> at 10:40...

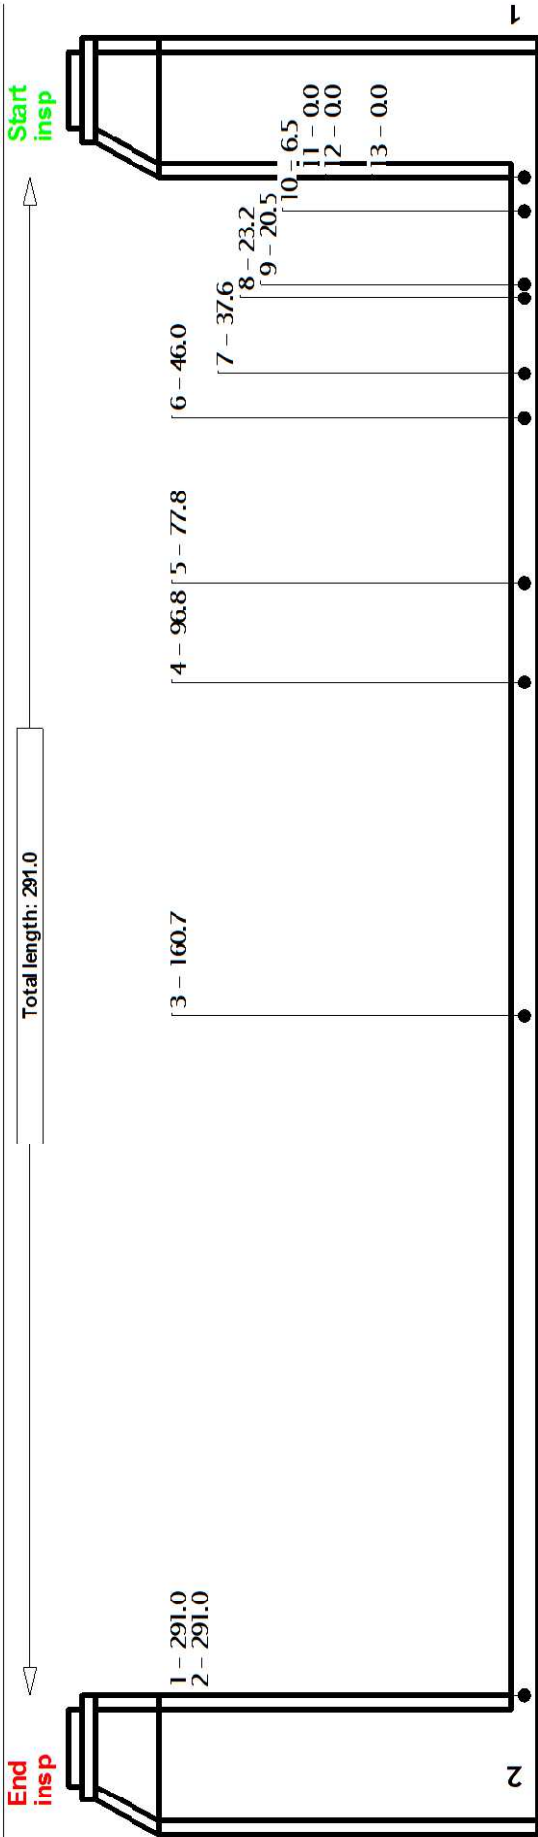
1 to 2
Upstream inspection

- 2 - 291.0 Manhole
Finishing manhole: 2
3 - 160.7 Miscellaneous Water Level 35.000 %
4 - 96.8 Miscellaneous Water Level 10.000 %
5 - 77.8 Deposits Settled Other 30.000 % At 3 To 9
DEBR
6 - 46.0 Deposits Settled Other 30.000 % At 3 To 9
DEBR
7 - 37.6 Miscellaneous Water Level 20.000 %
8 - 23.2 Miscellaneous Water Level 45.000 %
9 - 20.5 Joint Angular Medium
10 - 6.5 Fracture Spiral At 3 To 6
11 - 0.0 Miscellaneous Water Level 10.000 %
12 - 0.0 Manhole
Starting manhole: 1

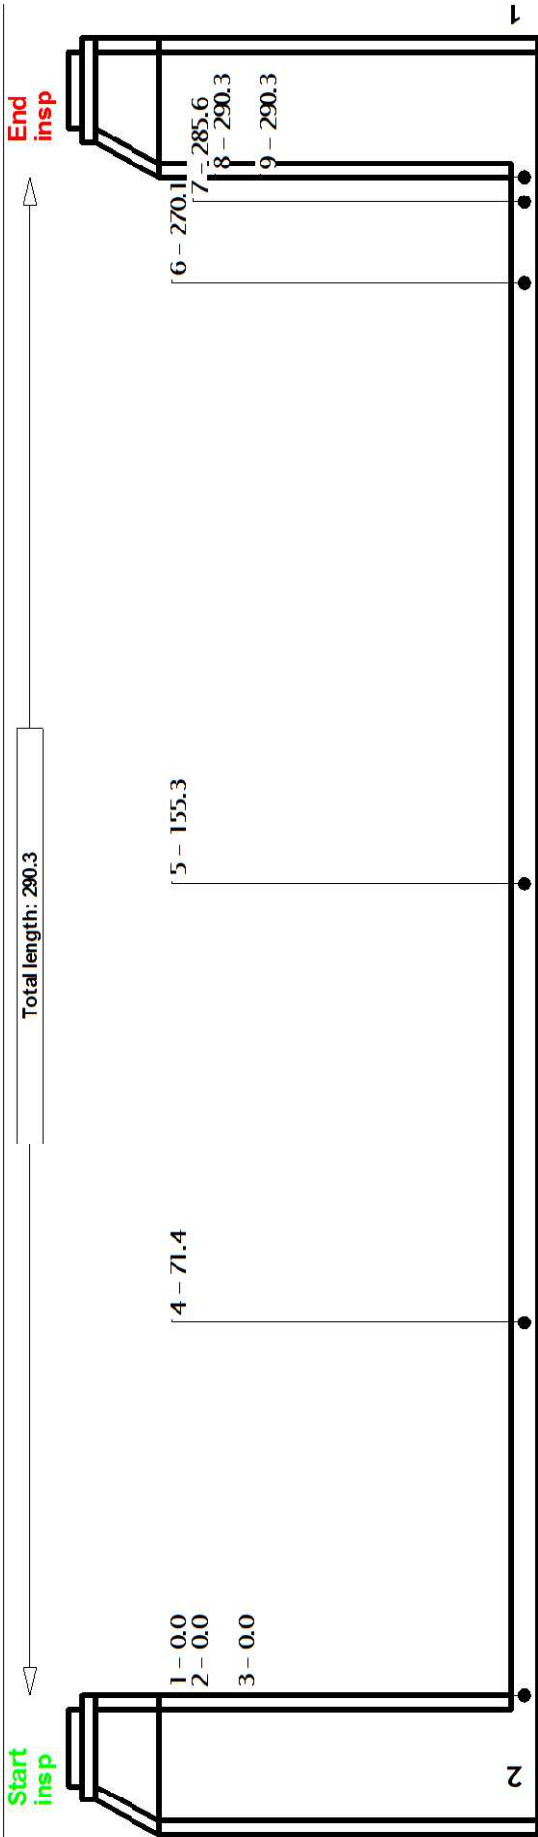
2 to 1
Downstream inspection

1 - 0.0 <Start inspection> at 10:31:32
2 - 0.0 Manhole
Starting manhole: 2
3 - 0.0 Miscellaneous Water Level 10.000 %
4 - 71.4 Miscellaneous Water Level 30.000 %
5 - 155.3 Miscellaneous Water Level 10.000 %
6 - 270.1 Joint Angular Medium
7 - 285.6 Fracture Spiral At 6 To 9 At Jnt
8 - 290.3 Manhole
Finishing manhole: 1
9 - 290.3 <Complete Inspection inspection> at 10:42:28

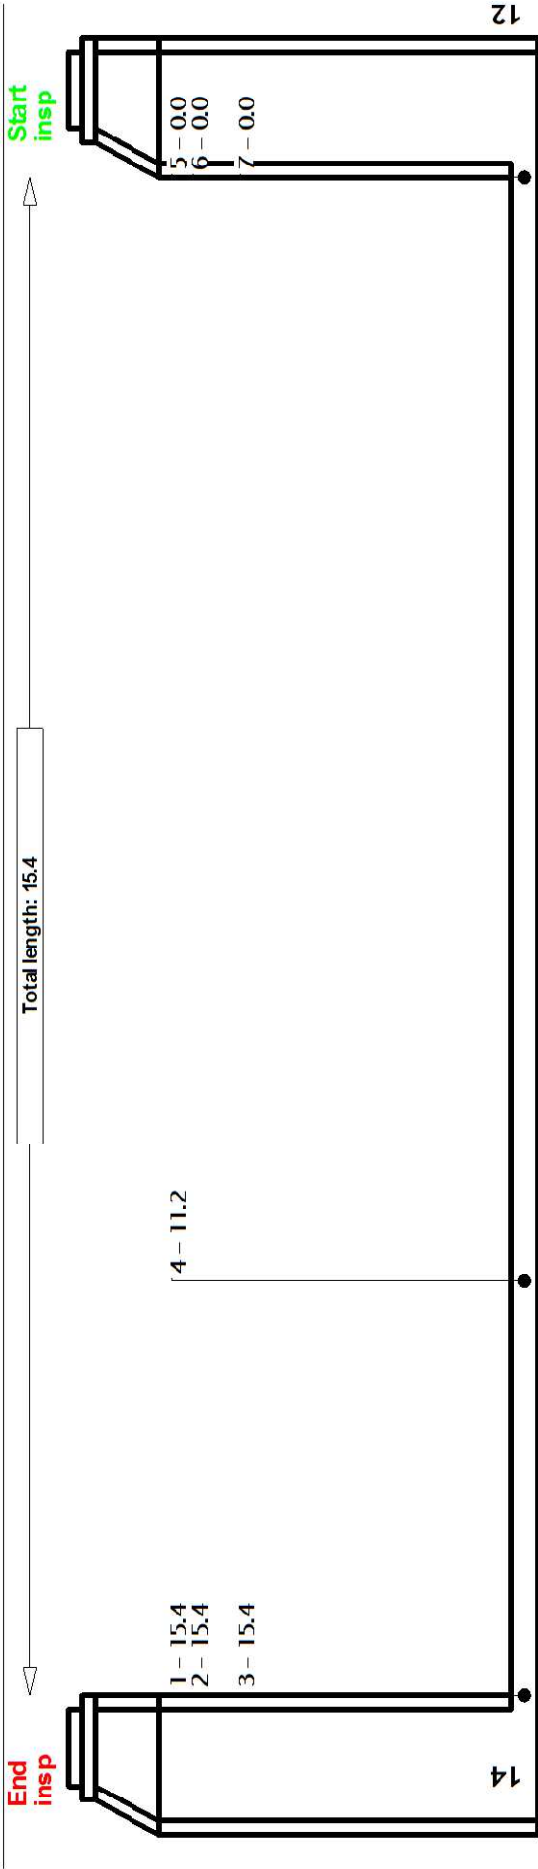
12 to 14
Upstream inspection

1 - 15.4 <Complete Inspection inspection> at 14:37:45
2 - 15.4 Access Point End of Pipe
Finishing manhole: 14
3 - 15.4 Obstruction Other 65.000 % At 2 To 10 At Jnt
ROOTS
4 - 11.2 Roots Medium Joint 40.000 % At 2 To 10 At Jnt
5 - 0.0 Miscellaneous Water Level 5.000 %
6 - 0.0 Manhole
Starting manhole: 12
7 - 0.0 <Start inspection> at 14:33:15

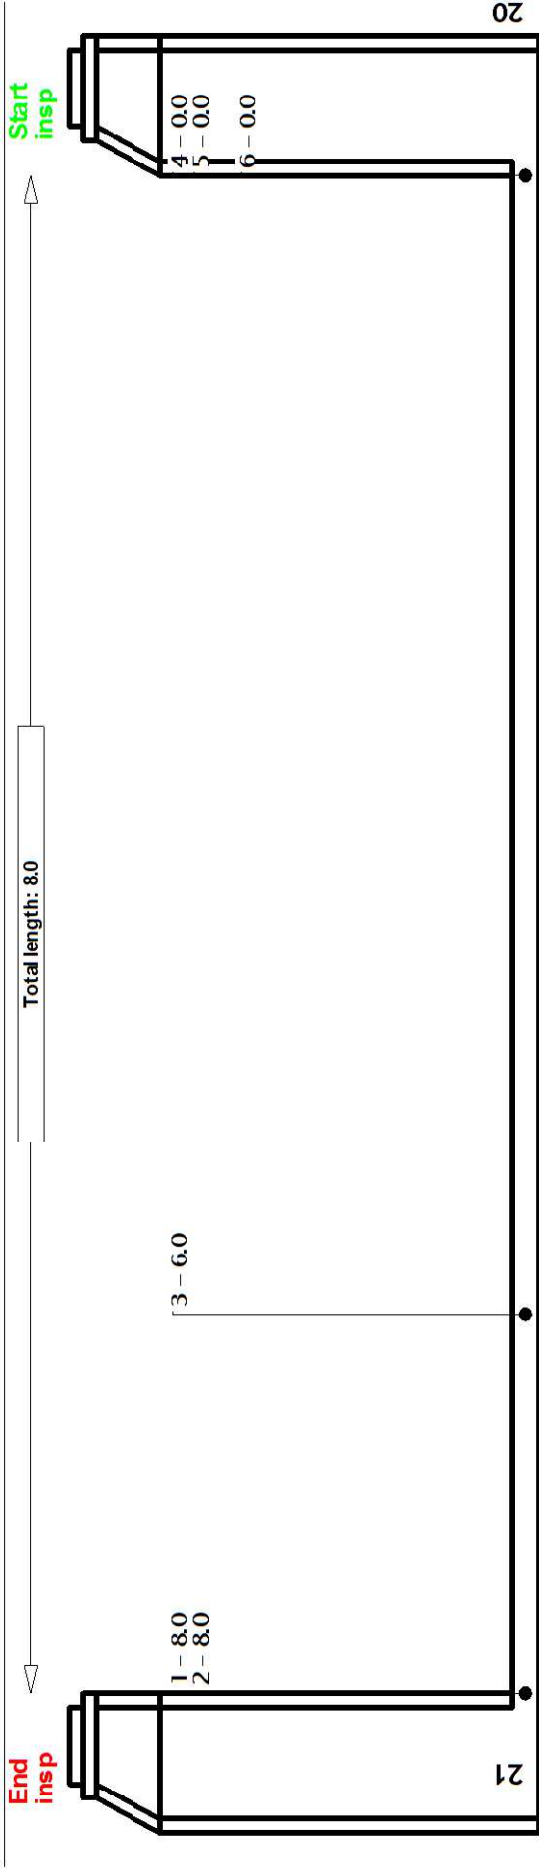
20 to 21
Upstream inspection

1 - 8.0 <Complete Inspection inspection> at 11:29:54
2 - 8.0 Access Point End of Pipe
Finishing manhole: 21
3 - 6.0 Deposits Settled Fine 35.000 % At: 3 To 9
4 - 0.0 Miscellaneous Water Level 0.000 %
5 - 0.0 Manhole
Starting manhole: 20
6 - 0.0 <Start inspection> at 11:25:34

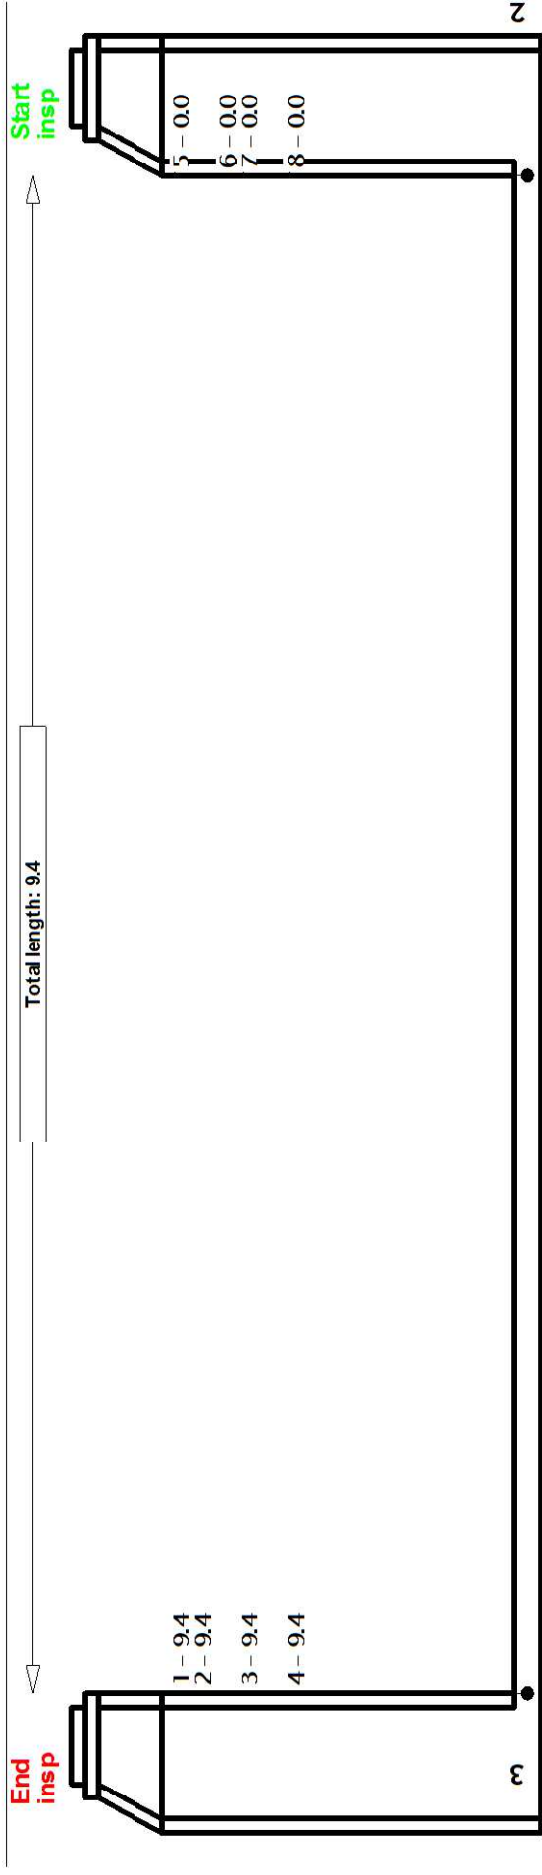
2 to 3
Upstream inspection

- 1 - 9.4 <Complete Inspection inspection> at 11:00:34
- 2 - 9.4 Miscellaneous Survey Abandoned
- 3 - 9.4 Deposits Settled Other 25.000 % At 4 To 8
- 4 - 9.4 Deposits Settled Other 75.000 % At 2 To 10
- 5 - 0.0 Deposits Settled Other 25.000 % At 4 To 8
- 6 - 0.0 Miscellaneous Water Level 5.000 %
- 7 - 0.0 Manhole
- 8 - 0.0 <Start inspection> at 10:56:41

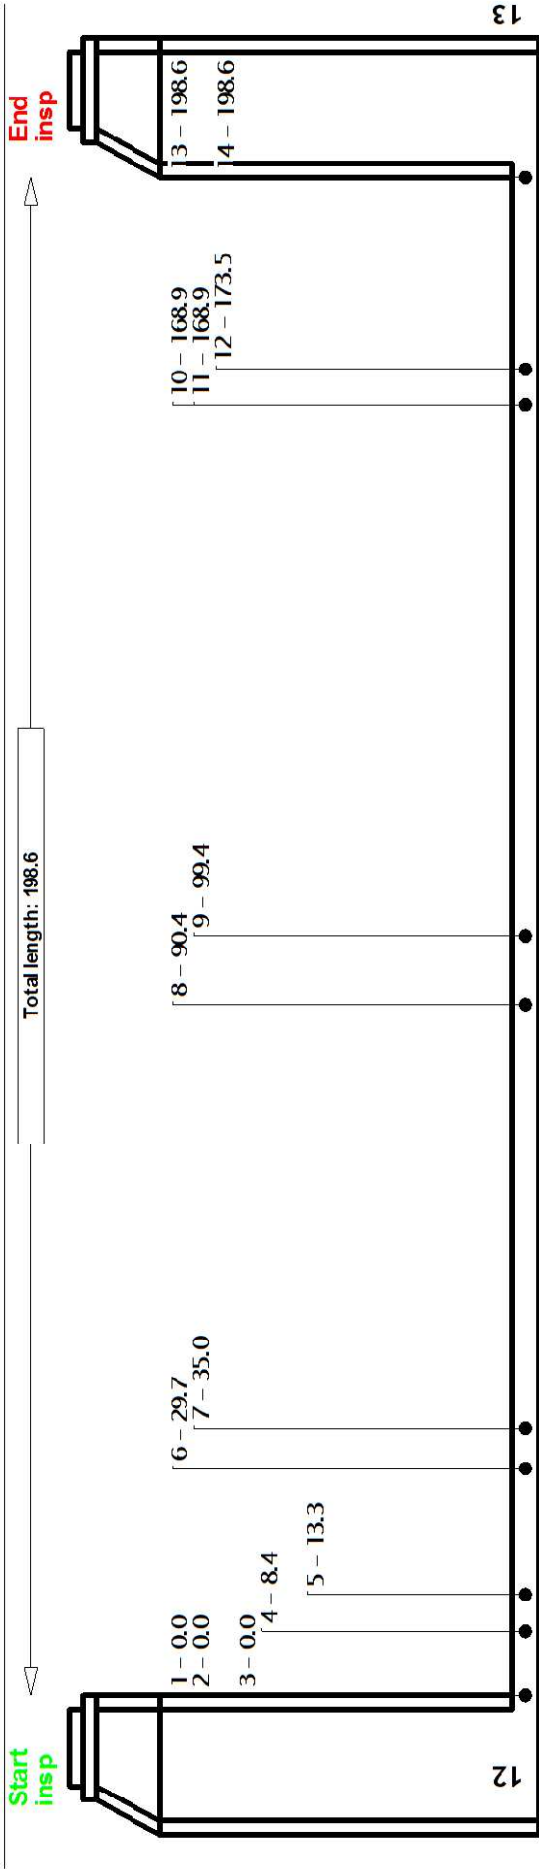
12 to 13
Downstream inspection

1 - 0.0 <Start inspection> at 14:05:30
 2 - 0.0 Manhole
 Starting manhole: 12
 3 - 0.0 Miscellaneous Water Level 20.000 %
 4 - 8.4 Miscellaneous Material Change
 Material changes TO VCP
 5 - 13.3 Miscellaneous Shape/Size Change Vert 8.000
 6 - 29.7 Joint Angular Medium
 7 - 35.0 Joint Angular Medium
 8 - 90.4 Fracture Longitudinal At 4 At Jnt
 9 - 99.4 Roots Fine Joint At 10 To 11 At Jnt
 10 - 168.9 Roots Fine Joint At 8 To 10 At Jnt
 11 - 168.9 Roots Fine Joint At 2 To 4 At Jnt
 12 - 173.5 Roots Fine Joint At 8 To 4 At Jnt
 13 - 198.6 Manhole
 Finishing manhole: 13

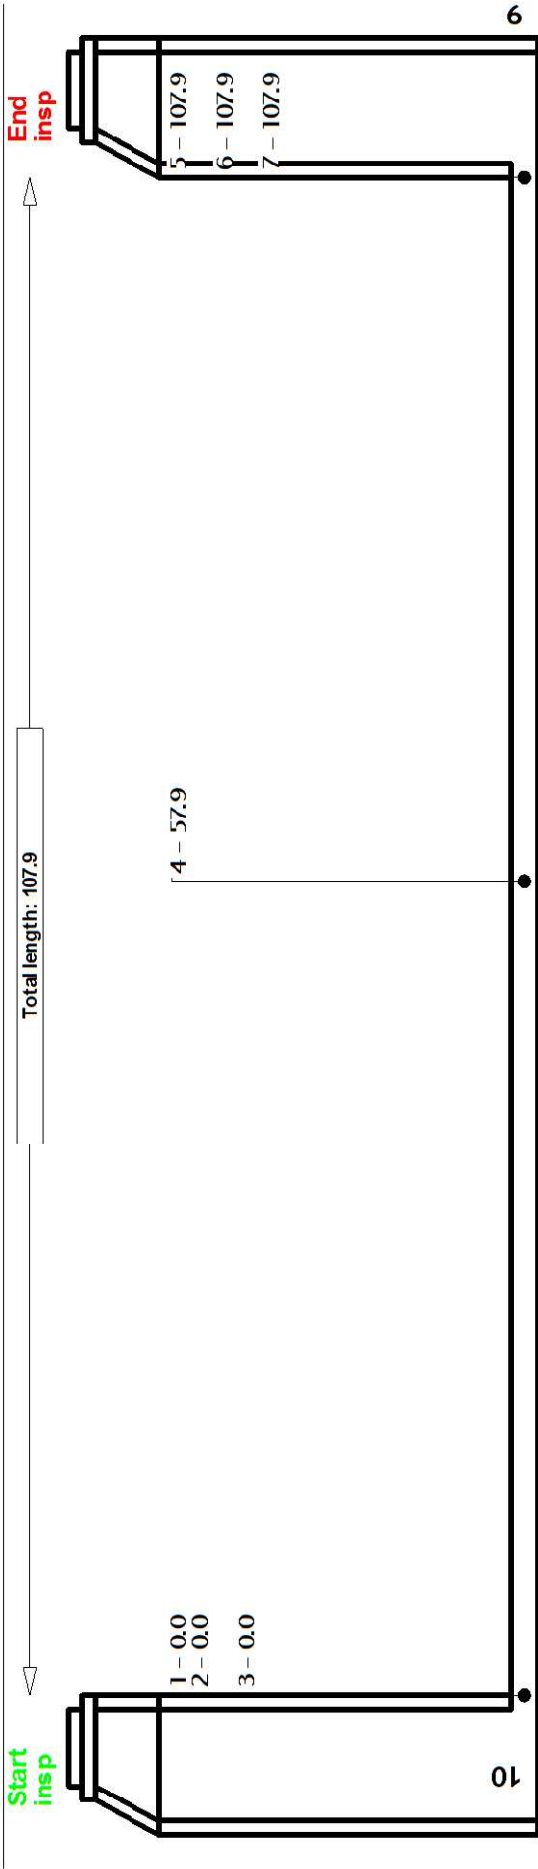
10 to 9
Downstream inspection

1 - 0.0 <Start inspection> at 12:55:44
2 - 0.0 Manhole
Starting manhole: 10
3 - 0.0 Miscellaneous Water Level 5.000%
4 - 57.9 Joint Angular Medium
5 - 107.9 Obstruction Other 95.000% At 12 To 12
WAD OF TOILET PAPER
6 - 107.9 Access Point End of Pipe
Finishing manhole: 9
7 - 107.9 <Complete inspection> at 13:02:35

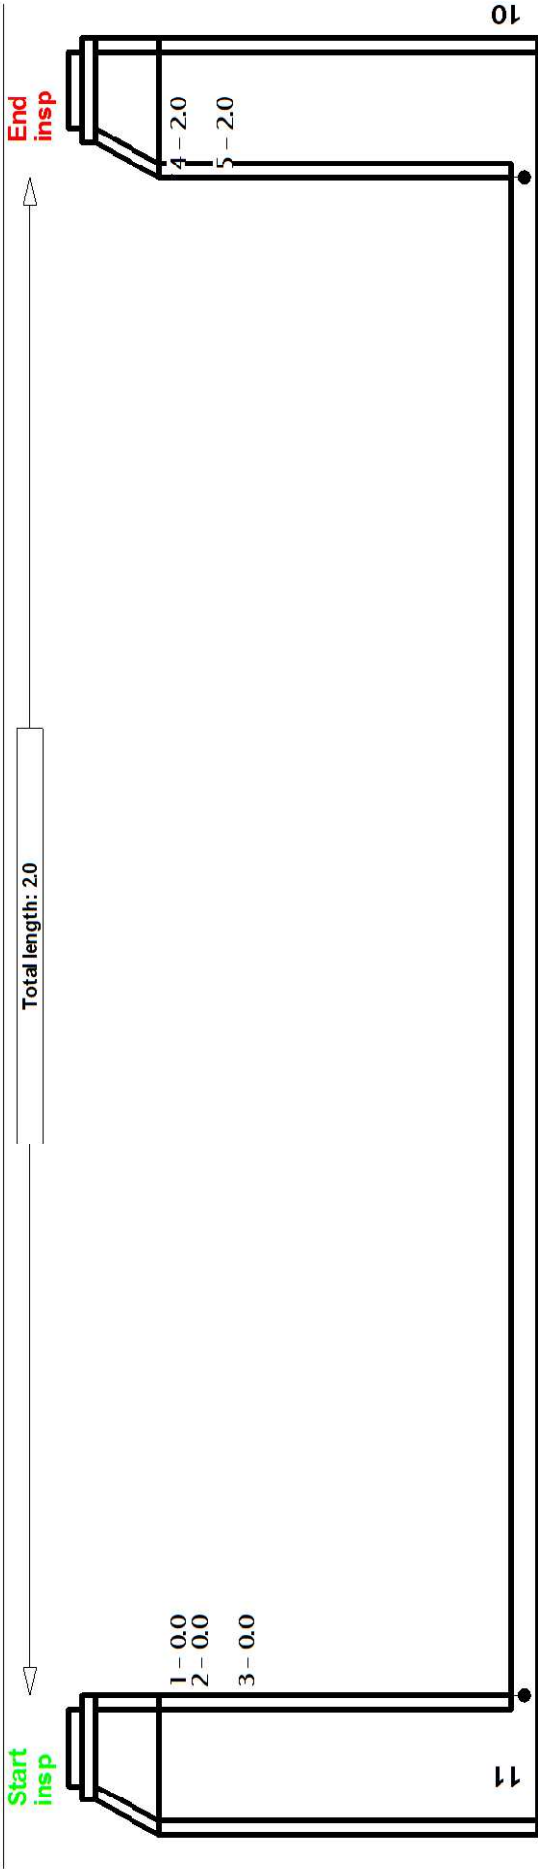
11 to 10
Downstream inspection

1 - 0.0 <Start inspection> at 12:33:35
2 - 0.0 Manhole
Starting manhole: 11
3 - 0.0 Miscellaneous Water Level 0.000%
4 - 2.0 Miscellaneous Survey Abandoned
Inspection abandoned No A...
5 - 2.0 <Complete inspection> at 12:35:02
