# Facility Evaluation for Fire Dept. Transport Study

City of Traverse City

April 25, 2022

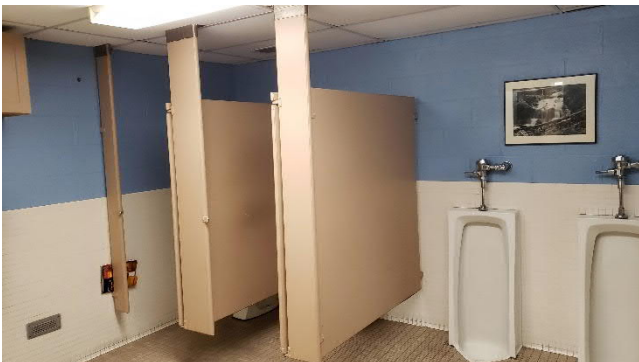
Figure A1.37

The current Men's only restroom (Figure A1.37) has 2 water closets, 2 floor mounted urinals, 2 shower stalls and 3 lavatories. The overall condition is good, however, the wing wall has broken/missing ceramic tile (Figure A1.38) on the top surface corner and is non-compliant to ADA and MI-BF requirements, though, not necessary to be for a fire station use. The toilet partitions are the original ceiling and wall hung painted metal pieces that appear to be in good shape, but painted several times.

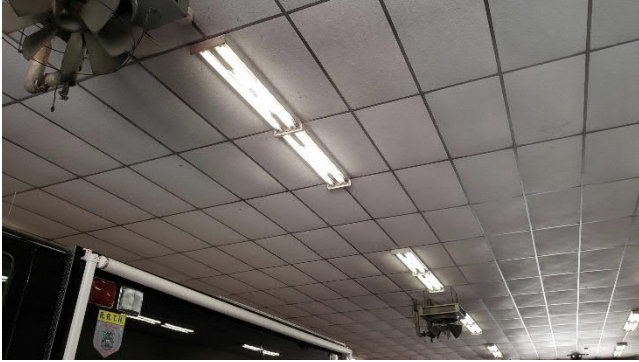
Figure A1.41

Suspended 2x4 acoustic tile ceiling systems are prevalent throughout the facility including the apparatus bay. The tiles are sagging due to age and moisture absorption (Figure A1.41) over the years with water stains in several rooms (Figures A1.39 and A1.40) from roof leaks. Following the repair of any roof leaks, it is recommended to replace the ceiling tile and grid as it will improve the overall appearance of the spaces. The workout room (former locker room) now has painted exposed roof structure (black). The bottom side of any exposed precast concrete floor panel is painted on the main floor and unpainted in the basement.

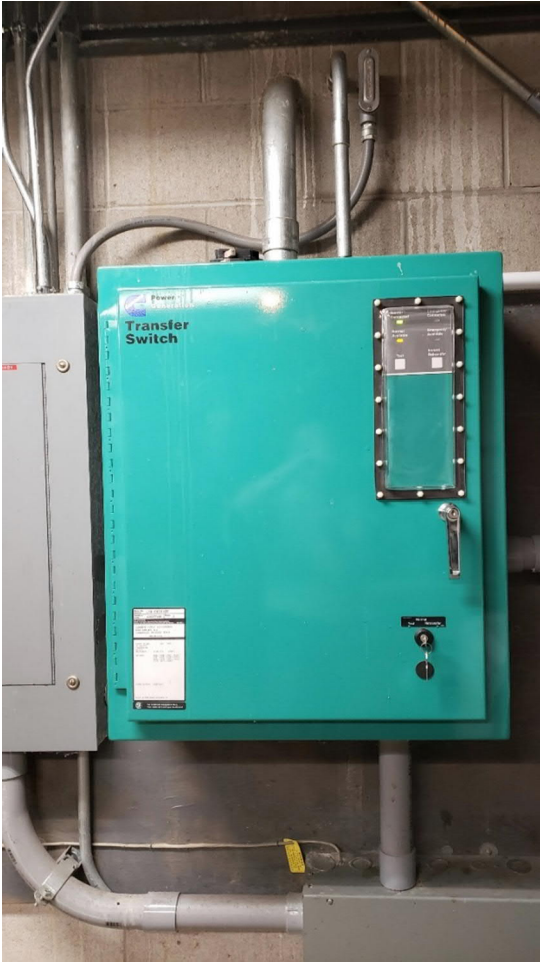
Electrical service to the Traverse City Fire Station #1 is via an underground feed from Traverse City Light & Power near the northeast corner of the building. A 35kW emergency diesel generator is located outside near the service entrance and supplies emergency loads for the building through an automatic transfer switch (ATS). It is fueled from an underground tank. This unit was built in 2003 and appears to be in fair condition. The main service and emergency panels are both rated 120/240V, single phase, 3 wire. The main panel is 200A and emergency is 150A. Each panel appears to be original to the building and have exceeded the manufacturer's recommended service life.

Figure E1.3 Automatic Transfer Switch (ATS)

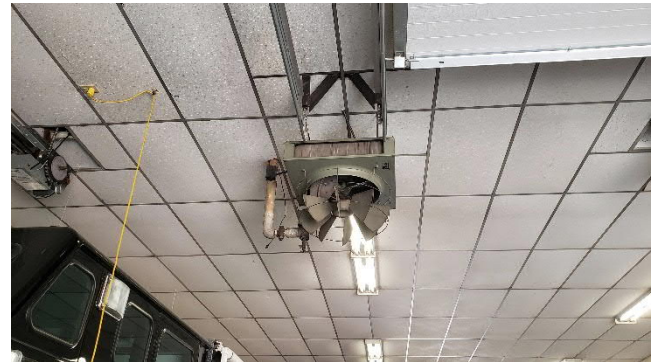
Figure M1.2 Apparatus Bay Unit Heater (typical of 4)

Heat transfer equipment is combination of baseboard finned tube convectors located on the exterior walls of the occupied spaces, ceiling-mounted vertical hot water unit heaters in the Apparatus Bay and Training Room, and a heating-only air handling unit with serves the dormitory and fitness room. Although all of these terminal heating units are functional, they are old and should be replaced in the near future. Newer heating units will provide for improved occupant comfort, controllability and energy efficiency.

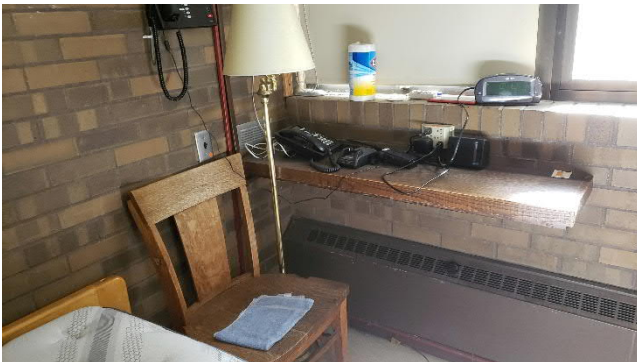
Figure M1.3 Typical Perimeter Heating Unit

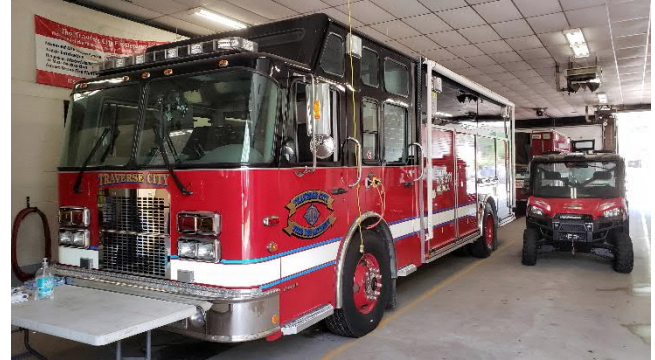
The Apparatus Bay currently has no vehicle exhaust detection and ventilation system. For the safety of building occupants, it is recommended that a new vehicle exhaust detection system be installed to monitor for unsafe levels of carbon monoxide and nitrogen dioxide. The system would include alarm devices as well as an exhaust fan to purge the bay with fresh air. It is also recommended that some form of exhaust capture equipment be added to the Apparatus Bay to minimize the accumulation of exhaust gases. Common capture systems include AirVac911 suspended units or PlymoVent snorkel units.

Figure M1.14 Apparatus Bay (no vehicle exhaust capture)

16. Add vehicle exhaust detection and ventilation system for Apparatus Bay. For the safety of building occupants, it is recommended that a new vehicle exhaust detection system be installed to monitor for unsafe levels of carbon monoxide and nitrogen dioxide. The system would include alarm devices as well as an exhaust fan to purge the bay with fresh air for meet current code requirements.

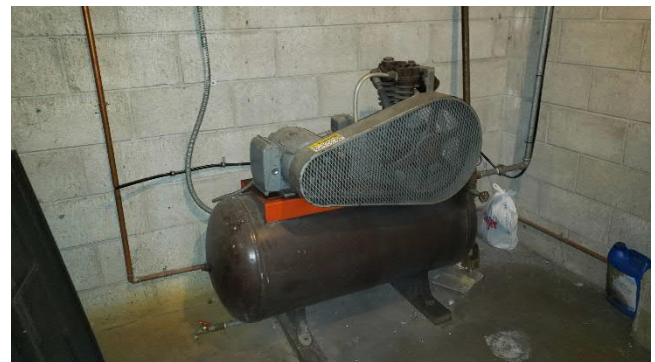
The temperature controls for the Station are primarily the original pneumatic (compressed air) devices. Each space has a thermostat which controls modulating heating valves for the heating units. Each A/C unit includes a separate temperature sensor for cooling set points. An air compressor in the basement provides the pneumatic air supply for the thermostats and control valves. These legacy pneumatic controls have far exceeded their life expectancy and provide very limited controllability. It is recommended that the temperature controls for the Station be completely upgraded to programmable direct-digital control (DDC) devices with a central building automation system.

Figure M1.16 Air Compressor for Temperature Controls

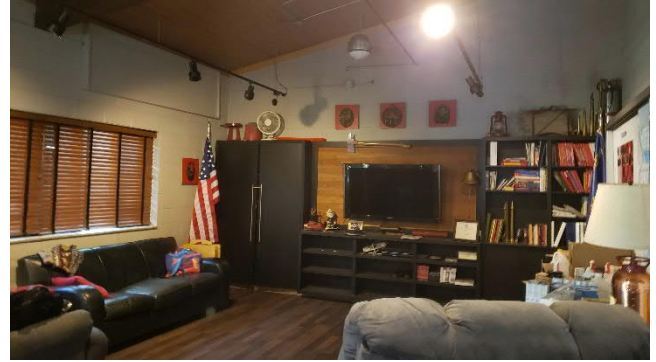
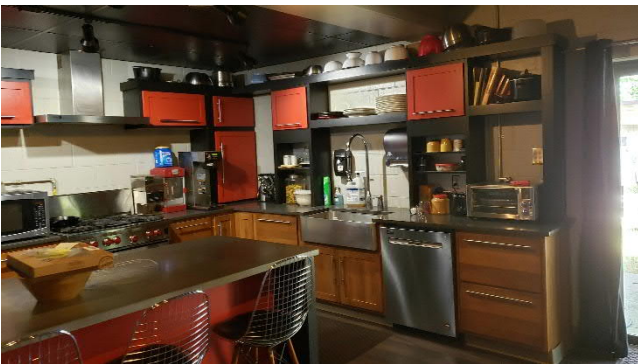
In 2007 the day room, kitchen, and front office was remodeled on HGTV's 'Carter Can' reality show (Figures A2.2 and 2.3) along with the boiler being replaced. The sleeping quarters, fitness room, and restrooms were refinished later (2014?) and, similar to the 'Carter Can' remodeling, removed the 2x4 suspended grid ceilings to expose the sloped wood deck roofing above. The roof was replaced with new single ply roof membrane over new rigid insulation (4" total?) to maintain the R-value of the removed ceiling batt insulation (8"?). Newer (in 2007?) 1" insulated glass in dark anodized aluminum frame windows replaced the original units with operable (sliding) sashes for natural ventilation. New passive attic vents (2) (Figure A2.4) were added at both the north and south gable walls over the apparatus bay doors to ventilate the attic more effectively. It appears the apparatus bay is the only space remaining that has an insulated suspended ceiling system in the building.

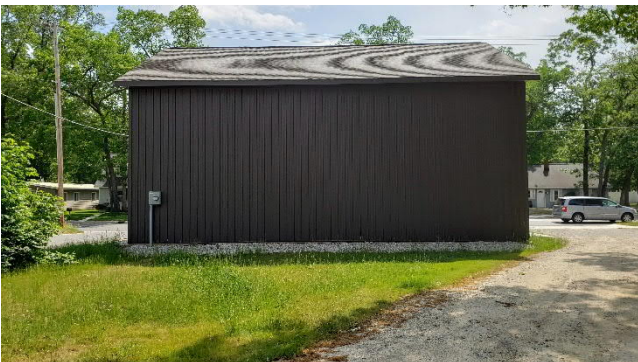
Figure A2.7

Parking for firefighters is along the north side of the building on either side of the apparatus bay door for 6 vehicles on pavement. There is gravel drive access to a new 20'x35' (+/-) cold storage building (Figure A2.7) recently constructed at the northeast corner of the property (appears to be built the same location and size as the old wood framed garage it replaced). The east side-yard is used to store fire department trailers (Figure A2.8) and equipment open air. The front yard along Eighth Street has an old wheeled water pump and the original steel tube flag pole that is rusty and in poor condition (Figure A2.9).

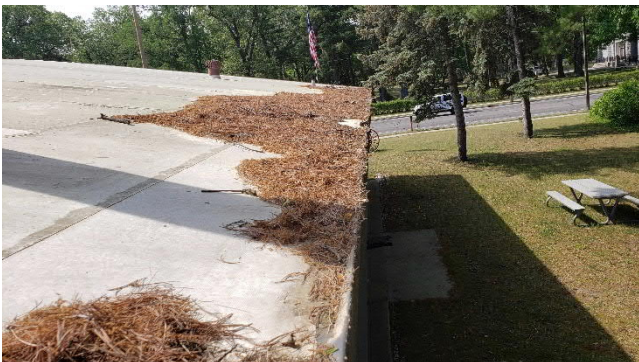
Figure A2.11

The 2-1/2:12 pitch roof consists of a white single ply membrane over rigid insulation of unknown depth and R-value, but appears to be older with the scrim (reinforcing mesh) reading through the membrane and along most of seams (Figure A2.10). The flashings around roof penetrations look to be in good condition with no known leaking problems. There was a build-up of pine needles along the west roof eave caused by the raised metal roof edges that make a 1" high dam (Figure A2.11). There are no gutters and downspouts to control water runoff, so rain sheet drains over the edges. We would recommend taking roof cores to evaluate the roof insulation condition and R-value (unless known) and replacing the roof membrane.

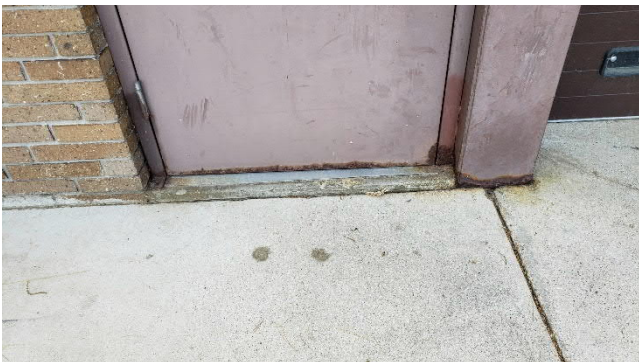
Figure A2.13

The all-masonry building is in good condition with no observed settlement cracks and some minor brick deterioration. The only concerns are the bases of the steel composite columns (Figure A2.13) at the apparatus bay overhead doors (all opening jambs and center column at south doors) show signs of rusting that need to be inspected and repaired. There are several original wall vents/louvers on the east and west walls that have been blocked and sealed from the inside.

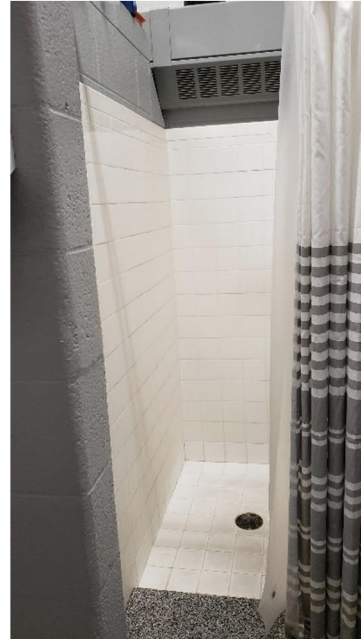
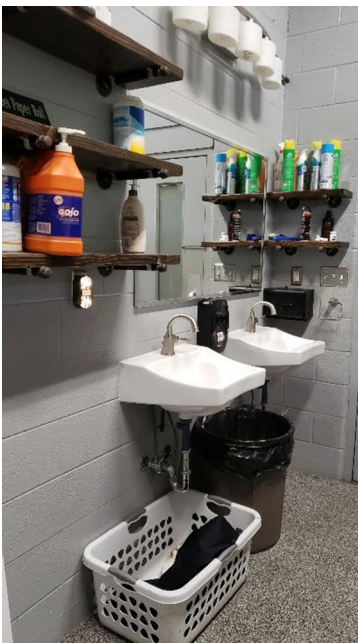
The current Men's only restroom has 2 water closets, 2 floor mounted urinals, 2 shower stalls and 2 lavatories (Figures A2.19 and A2.20). The overall condition is good and recently redecorated, however, is non-compliant to ADA and MI-BF requirements, though, not necessary to be for a fire station use. The painted metal toilet partitions are floor supported and are in fair condition. There is no restroom provided in the west portion of the facility.

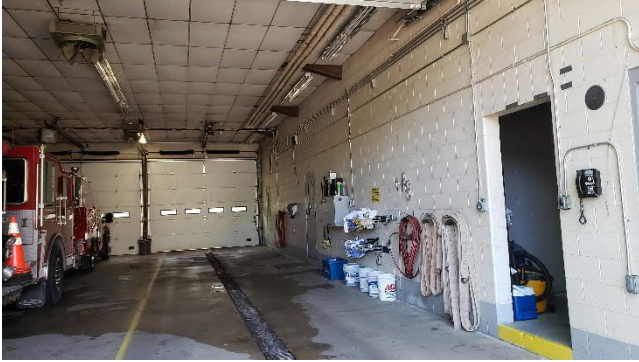
Figure A2.22

Suspended 2x4 acoustic tile ceiling systems are only in the apparatus bay, office and newer 2x2 in the kitchen area of the day room. The 2x4 tiles are sagging (Figures A2.22 and A2.23) due to age and moisture absorption over the years. The rest of the building is open to the wood roof deck and in good condition. The remainder of the ceilings are exposed tongue and groove stained wood deck.

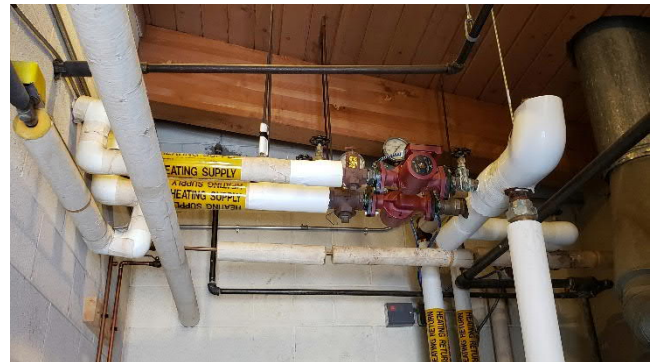
Figure M2.4 Heater System Zone Pumps

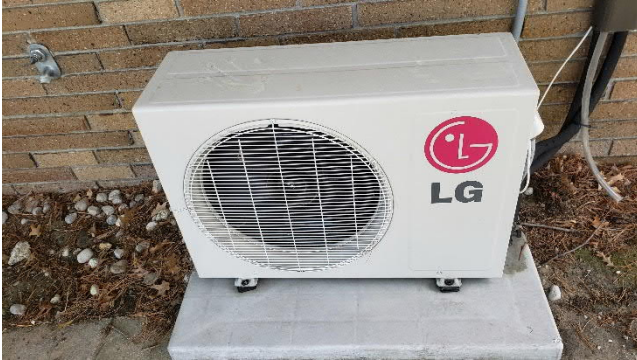
Figure M2.5 Mini-Split A/C Unit (outdoor condenser)

16. Remove existing small A/C units and provide a central ventilation and air-conditioning system to serve all occupied and living areas sized to meet current ventilation and indoor air quality standards.

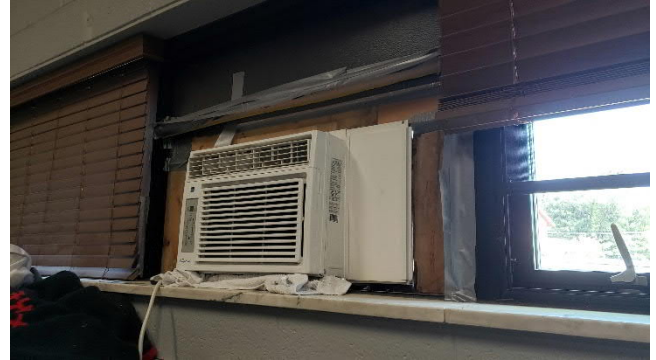
Figure M2.6 Dormitory Window A/C Unit

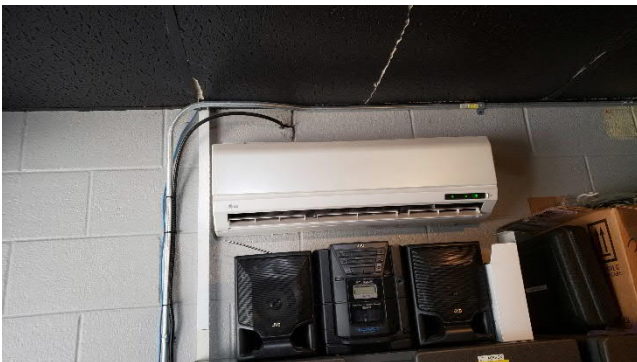
Figure M2.7 Mini-Split A/C Unit (indoor evaporator)

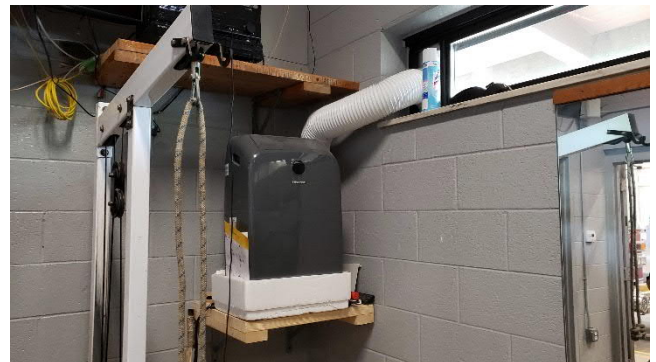
Figure M2.8 Fitness Room Portable A/C Unit

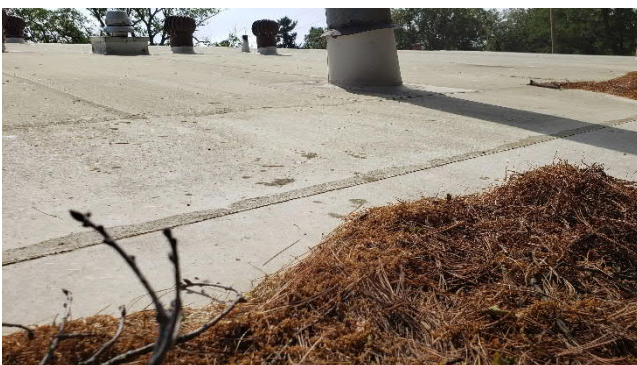
Figure M2.9 Rooftop Exhaust Fan

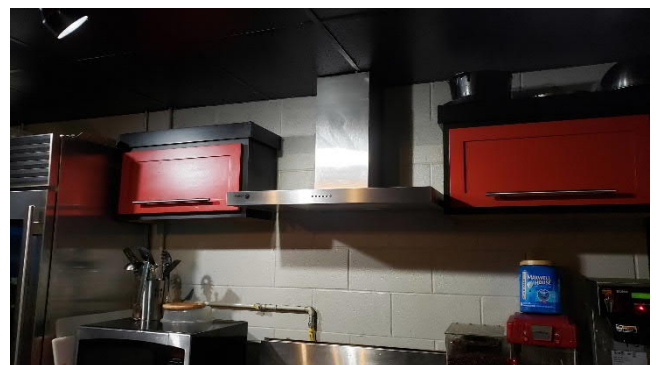
Figure M2.10 Kitchen Range Exhaust Hood

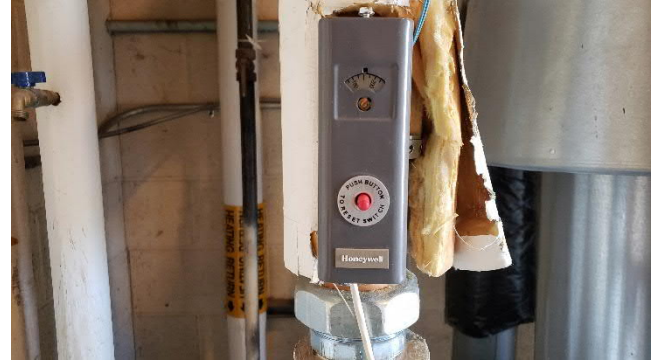
Figure M2.14 Typical Stand-Alone Control Device

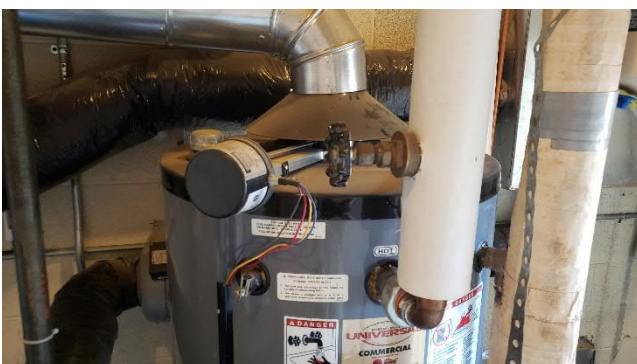
Water is supplied by a 1-1/2" metered service which enters at the building's northwest corner. A storage type atmospheric vent gas fired storage type domestic water heater provides hot water to building lavatories, sinks and showers; unit is rated at 199,999 input Btuh with 91-gallon storage volume. The heater is equipped with an automatic flue damper and the hot water distribution system includes an aquastat-controlled return water circulation pump.

Figure M2.15 Domestic Water Heater

19. Remove and replace heating supply and return piping.
20. The existing gas-fired water heater should be upgraded to a heat pump unit for improved energy efficiency and alignment with EPA water heating equipment standards.

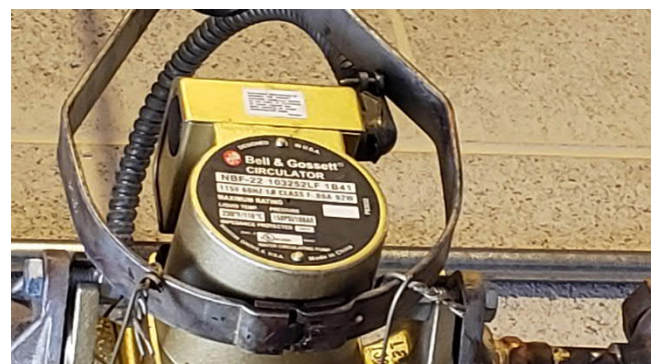
Figure M2.16 Domestic Hot Water Recirculator
