Operations Management Services

2015-2016 Annual Operations Report

Traverse City Regional Wastewater Treatment Plant

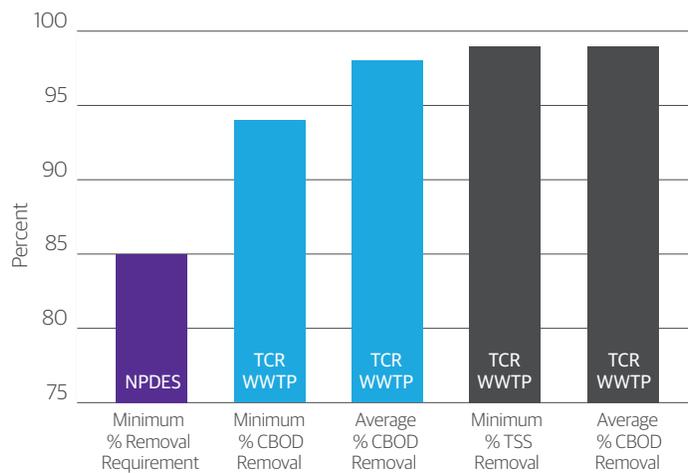
Exhibit 1
2015-2016 TCRWWTP Percent Removals vs NPDES Permit Requirement

The plant is required to remove, at a minimum, 85 percent of the Influent CBOD and TSS. Exhibit 1 illustrates the plant percent removals for 2015-2016. Exhibit 2, contains NPDES permit effluent concentration (milligrams per liter [mg/L]) limits compared to the actual average effluent concentrations for 2015-2016.

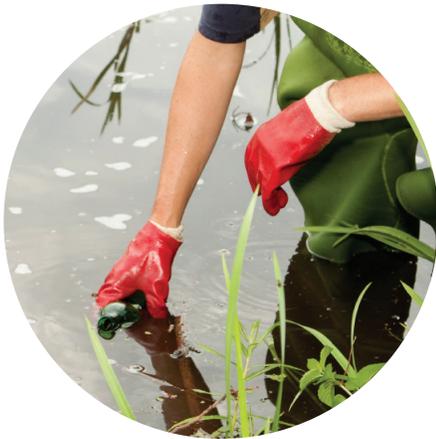
Exhibit 3

2015-2016 NPDES Permit Average Concentration Requirement vs Plant Effluent Average Ammonia Nitrogen Concentration

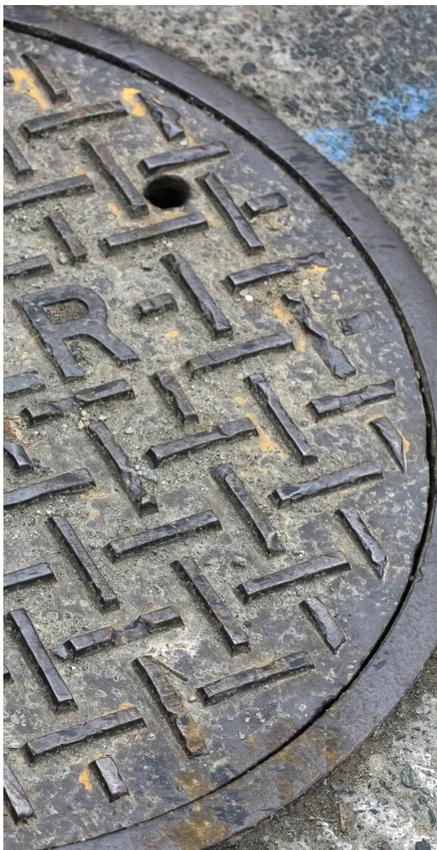
Exhibit 11

IPP Items Responded to July 2015-June 2016

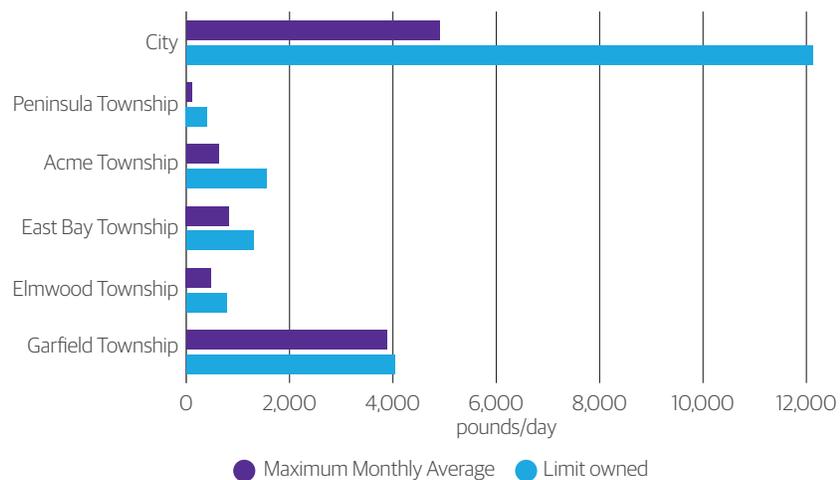
Exhibit 13
Owned Capacity vs Maximum Monthly Average Loadings 2015-2016

As part of CH2M's contractual obligation to the City, we operate and maintain eight automatic flow proportioned samplers strategically placed throughout the collection system in order to obtain representative samples from each of the following townships: Garfield, East Bay, Acme, Elmwood, and Peninsula. We collect three samples a week, and each sample is analyzed to determine its BOD concentration. These concentrations are used to calculate a monthly average BOD concentration. The average monthly BOD concentration for each township and monthly township flow values (provided by the County) are used to calculate the BOD loadings from each of the fore mentioned townships, the City, and Blair Township. (Exhibits 13 and 14 summarize the 2015-2016 BOD loadings vs owned capacities.)

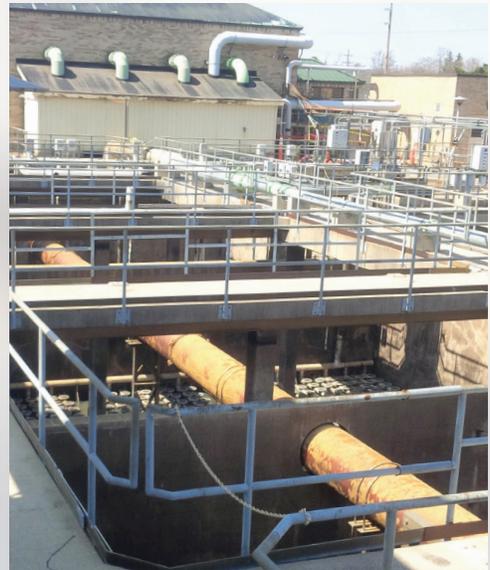
We cleaned the south aeration basin, and made some minor repairs to the aeration grid. The cleaning of the basin and its ceramic aerating diffusers optimizes air transfer throughout the basin and reduces electrical cost related to aerating the basin.

South aeration basin cleaning.

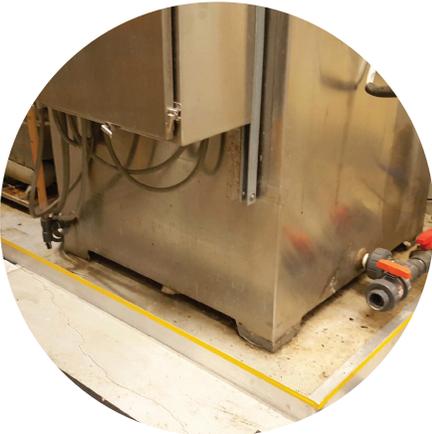
Containment structures around US Filter Polymer.

- Replaced the failed Maxon valve on boiler #1
- Installed containment structures around the US Filter Polymer Units
- The doors to the maintenance shop and the aeration basin were replaced

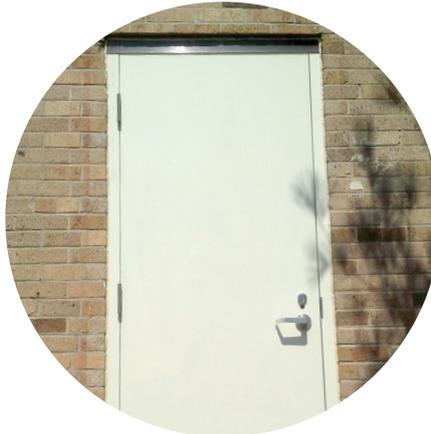
Shop door replacement.

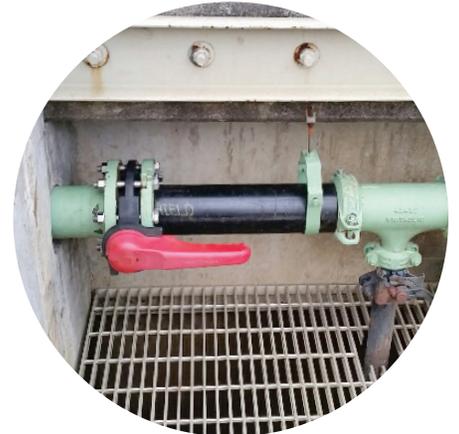
New isolation valve.

- Installed an isolation valve on the air distribution line for the membrane train distribution channel

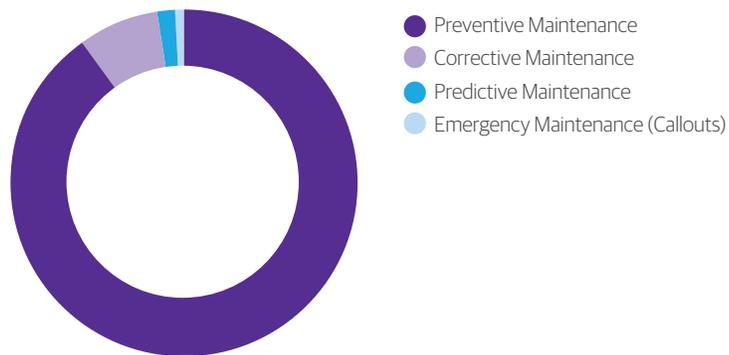
Exhibit 16
Maintenance Work Orders Completed 2015-2016

CH2M performed 2,562 work orders in 2015-2016. More than 90 percent of the work orders were for preventive maintenance activities, or work that helps prolong the life of the City's assets. Exhibit 20 highlights our maintenance work orders for 2015-2016.

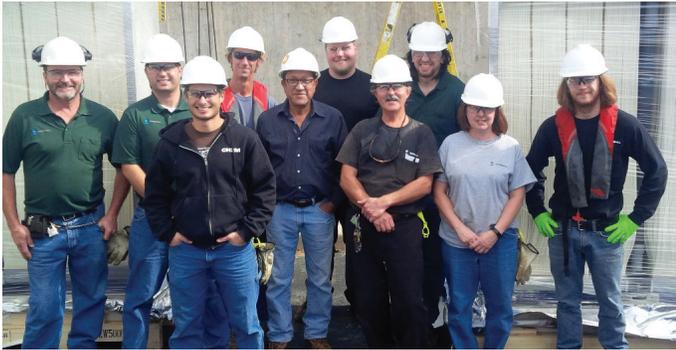
In 2015-2016, we replaced four membrane train effluent gates, two aeration basin gates, and four trains of 500C membranes with 500Ds membranes.

Traverse City membrane replacement team.

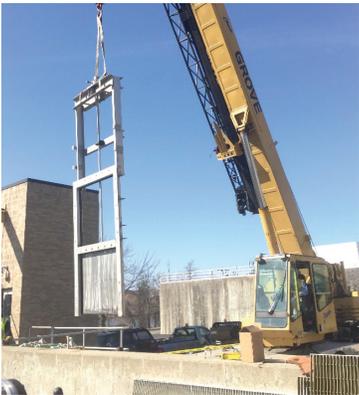
New gate being moved in place.

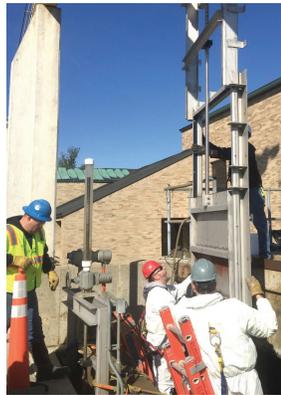
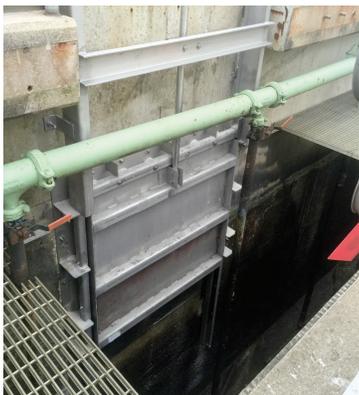
New gate in place.
